Great Lakes - St. Lawrence River Adaptive Management (GLAM) Committee

Annex 1:

Supplementary impact assessment information for Lake Ontario and the St. Lawrence River

November 26, 2018

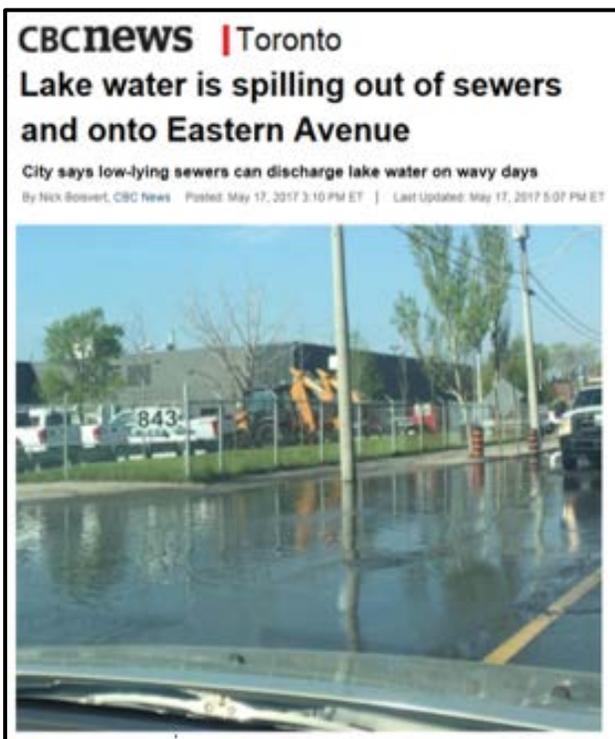
treatment. There was news coverage of several wastewater treatment facilities experiencing inflow surcharges as a result of storm water infiltration of the collection system, as well as a few accounts of releasing untreated sewage into the Niagara River and Lake Ontario. There has also been news coverage of inundated self-supplied and municipally serviced residential systems located in low-lying areas from high-water levels in Lake Ontario. For example, on May 2, 2017, the Hamilton Spectator quoted Hamilton City Councilor Chad Collins stating that “Although the City has installed new pumping stations and changed building rules to ban full basements in new beach strip housing, even in a “normal” year he still receives regular calls about spring flooding.” (<http://www.thespec.com/news-story/7271902-heavy-rains-batter-hamilton-s-waterfront-flood-basements/>). On May 17, 2017, CBC News reported that with the water much higher than usual, the City of Toronto was finding that a small number of the City's catch basins were now below the lake's surface level, forcing the water upwards in some cases (Figure 3-1) (<http://www.cbc.ca/news/canada/toronto/lake-water-is-spilling-out-of-sewers-and-onto-eastern-avenue-1.4120024>). On June 13, 2017 WHEC reported that the Town of Greece, NY suffered \$500,000 in infrastructure costs and that the Village of Sodus Point would receive \$500,000 from the State of New York to “repair the flood-damaged waste water system” (<http://www.whec.com/news/governor-cuomo-visits-flooded-areas-along-lake-ontario-tuesday-4511959/>).

Figure 3-1: News story from CBC News Toronto on May 17, 2017 (<http://www.cbc.ca/news/canada/toronto/lake-water-is-spilling-out-of-sewers-and-onto-eastern-avenue-1.4120024>)

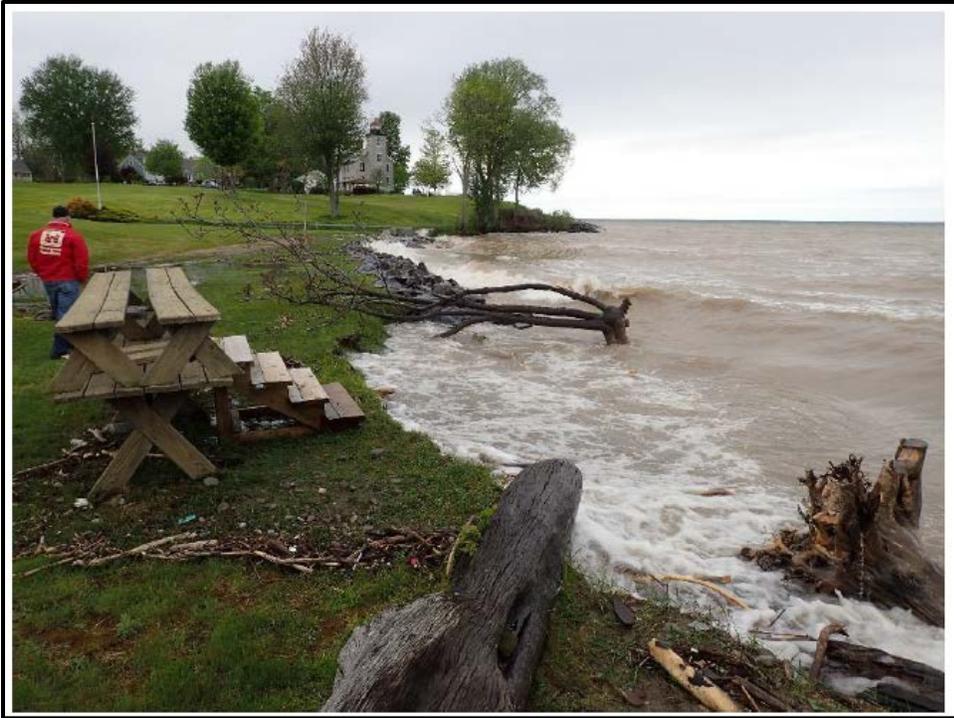
Figure 3-2: Shoreline erosion observed adjacent to sanitary sewer line in Sodus Point, NY, 19 May, 2017. Photo credit: USACE Buffalo, 2017.

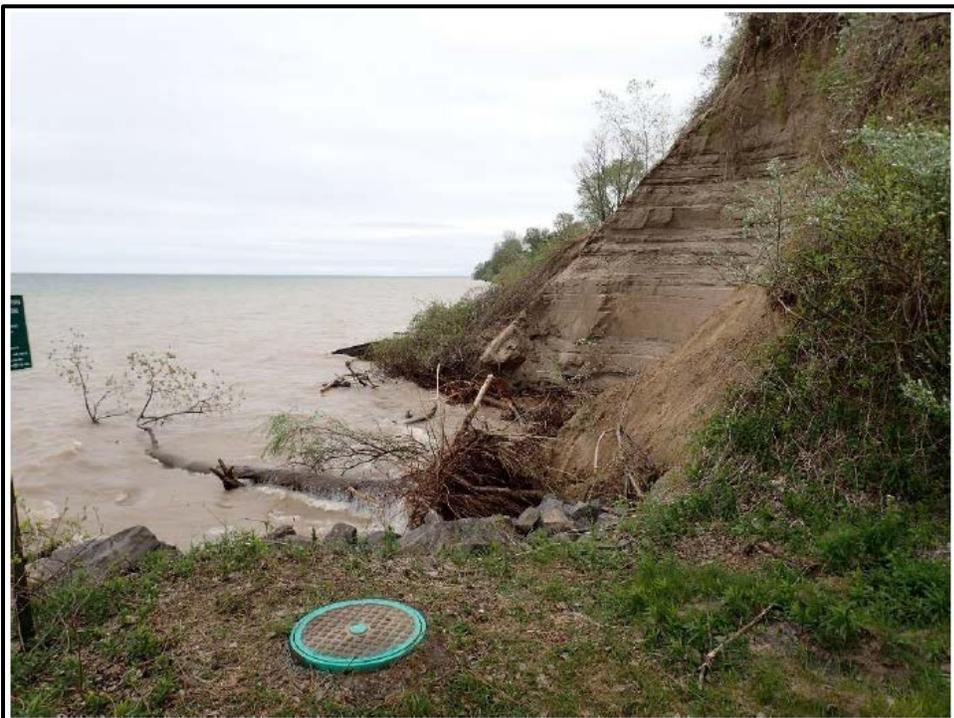
Figure 3-3: Bluff erosion approximately 10 ft. from WWTP outfall, in Sodus Point, NY, 19 May, 2017. Photo credit: USACE Buffalo, 2017.

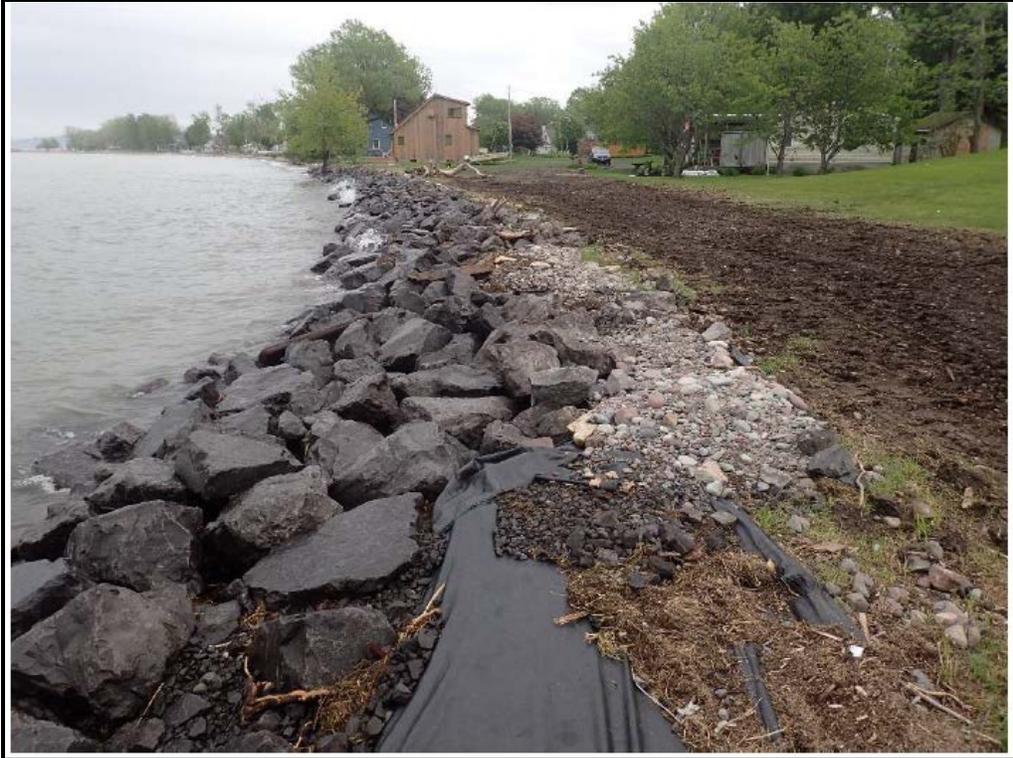
Figure 3-4: Additional rip rap placed to protect sanitary sewer line in Sodus Point observed on 26 May 2018 Photo credit: USACE Buffalo, 2017.

Additional impacts noted by the Buffalo office of USACE during site visits in May of 2017 include septic leach field inundation in Kendall, NY. The Ogdensburg Combined Sewer Outfall pumps were inoperable for a period in May due to the volume of water exceeding pump capacity, leading to high water above Combined Sewer Outfall outlets. In Oswego, NY, the sanitary sewer lift station at the end of West Shore Road becomes inundated as backwater from Wine Creek floods the nearby marsh and activates the pump alarm. Primarily driven by wind events and not static water levels, there was no observed inundation of the lift station during the site visit, however high water levels observed in the marsh are only approximately 12 in (0.3 m) from inundating the pump station. Local authorities had taken the preventative measure to stock sandbags next to the lift station. In Sandy Creek, NY all of these residences' septic systems were flooded at the Sandy Pond Beach Campground rendering all sanitary facilities inoperable at that site. In Wilson, NY, the town storm sewer outfall was truncated due to wave action, approximately 20 feet of the 30-inch diameter HDPE pipe was lost along with the protective stone bedding. Braley Road was closed due to erosion pockets and sink holes caused by a seepage path forming along the existing twin-arched corrugated metal pipe culverts. Wilson authorities were consulting with an Architecture and Engineering Firm at the time of the site visit to repair the culverts. Shoreline erosion along Lakestone Drive was observed to be threatening a sanitary sewer line and protective riprap had been lost due to wave action (Figure 3-2). The WWTP outflow at Featherly Drive was threatened with erosion (Figure 3-3). A follow-up site visit to Sodus Point on 26 May showed additional riprap protection was placed to protect the sanitary sewer line on Lakestone Drive (Figure 3-4).

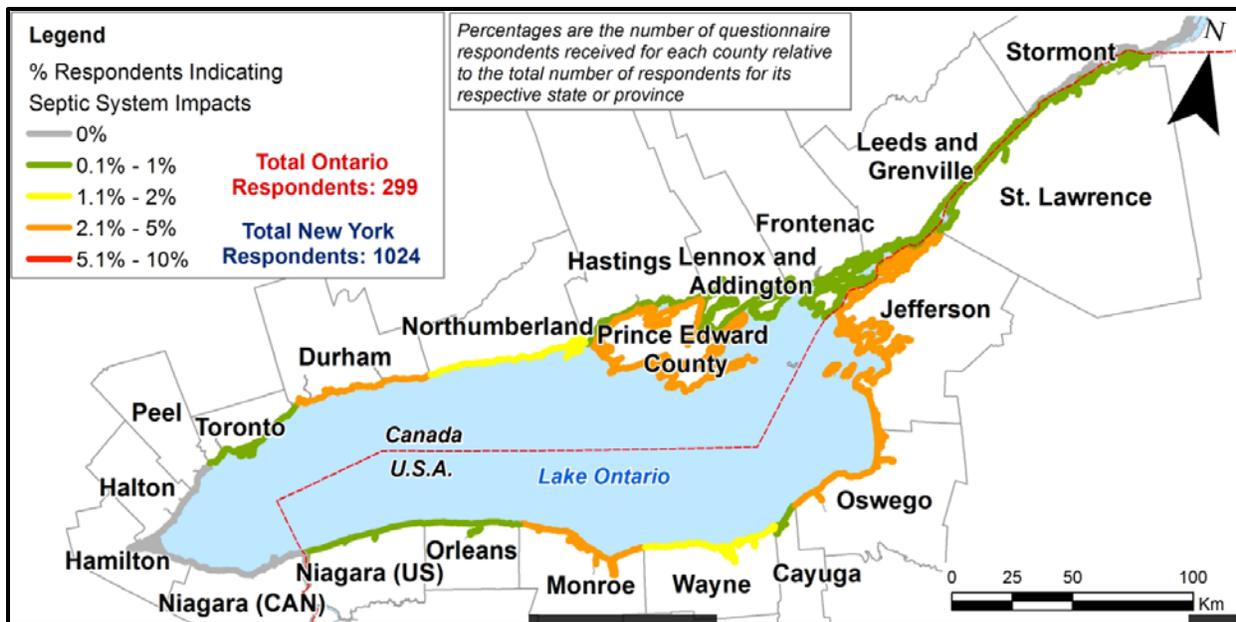
This information is consistent with preliminary results from the responses to the Conservation Ontario shoreline questionnaire regarding self-supply residential water and wastewater functions. From November, 2017 through January, 2018, Conservation Ontario collected responses to an on-line survey. Respondents answered questions regarding the observed impacts on their properties throughout 2017. This was a self-reporting survey and the GLAM Committee has not independently verified questionnaire responses, nor are the responses intended to be a statistically representative sample. Nevertheless, the responses provide information on the types of impacts that were identified by shoreline property owners. Impacts reported for the self-supply residential category included flooding of property features including wastewater treatment and potable water supply systems. On the US shoreline of Lake Ontario and the Upper St. Lawrence River, there were 1024 usable responses to the Conservation Ontario survey. Of those responses, 155 reported flooding or inundation or septic beds primarily in Oswego, Jefferson and Monroe counties, and the municipalities of Hilton, Hamlin, Sandy Creek and Mexico, each having greater than 10 responses. In terms of self-supply water, there were 100 respondents that indicated their shore wells flooded (Figure 3-5). The majority were in Jefferson and Monroe counties, with greater than 20 responses (Figure 3-6). Because this is not a statistically representative sample of shoreline impacts, the findings cannot be extrapolated to estimate full lake damages and further assessment is required to determine the full extent of septic and shore well impacts along the Lake Ontario and southern St. Lawrence River shoreline.

Figure 1-5: Percent of survey responses indicating septic flooding (shown as a %, by County, relative to total number of survey responses in that Country) (Source: Environment and Climate Change Canada (ECCC), based on data acquired through Conservation Ontario survey for IJC)

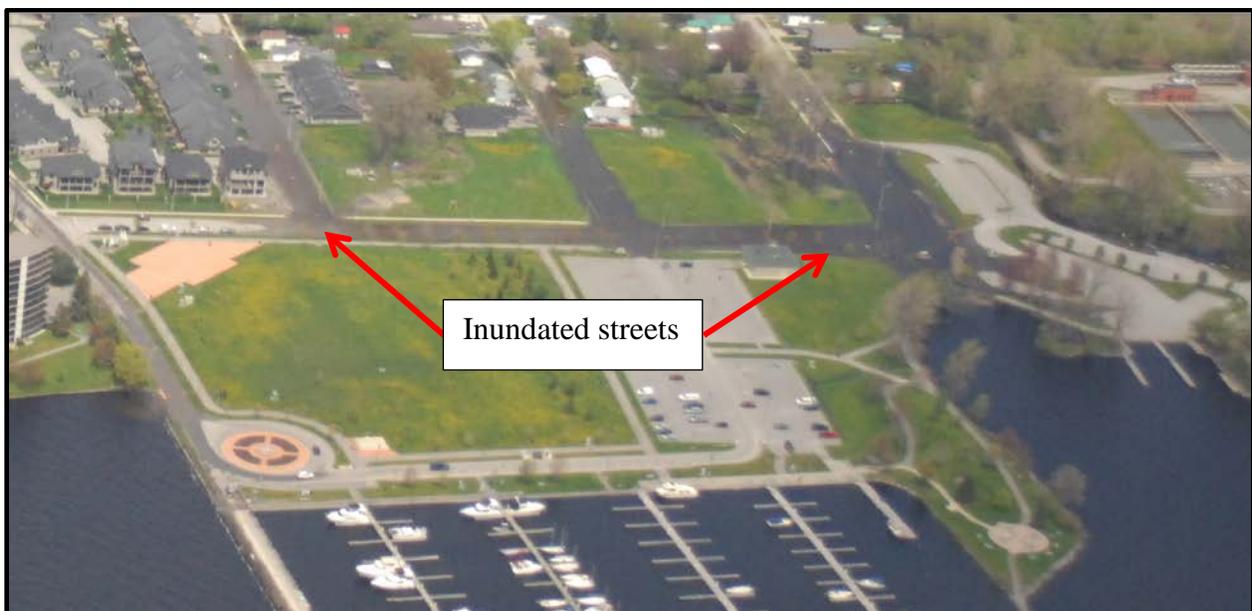
In Prince Edward County and within the jurisdiction of Quinte Conservation, submerged storm sewer outlets and wastewater effluent pipes were experienced during the high water period along with some sewer bypasses (presentation to fall 2017 Ontario Provincial Flood Forecasting and Warning Committee (PFFWC) workshop). There were also examples of erosion around shore wells as well as flooding of roads indicating drainage problems (see Figure 3-8 with an example from

Figure 3-8: Oblique imagery of street flooding in Belleville, ON, May 14th, 2017. Photo credit: Transport Canada National Aerial Surveillance Program, 2017.

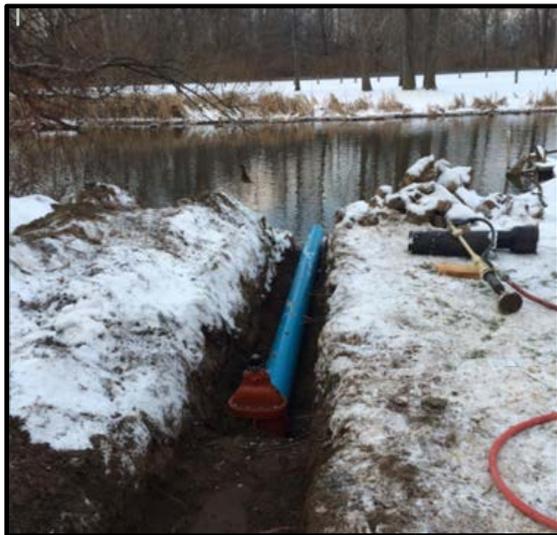
Figure 3-9: Installation of pipes and shut-off valve in Greece, NY as a flood response (Source: WHAM, Rochester, February 5, 2018 - <http://13wham.com/news/local/greece-adds-new-pipes-valves-in-high-risk-flood-locations>)

the US and Canadian shoreline of these water bodies. For example, both the City of Hamilton (City of Hamilton, 2017) and the Town of Niagara-on-the-Lake (<https://notl.civicweb.net/document/7696/Media%20Release%20-%20Town%20Executes%20a%20De-watering%20Progra.pdf?handle=97EC5196311E4AAC80019A579C3B255E>) incurred extra operating expenses to pump excess water from low lying areas directly adjacent to the lakeshore. The Town of Greece, NY installed new shut-off valves, pipes and a berm structure to help minimize flood damage in the future, according to a February 5th, 2018 news report from WHAM Rochester (<http://13wham.com/news/local/greece-adds-new-pipes-valves-in-high-risk-flood-locations>) (Figure 3-9).

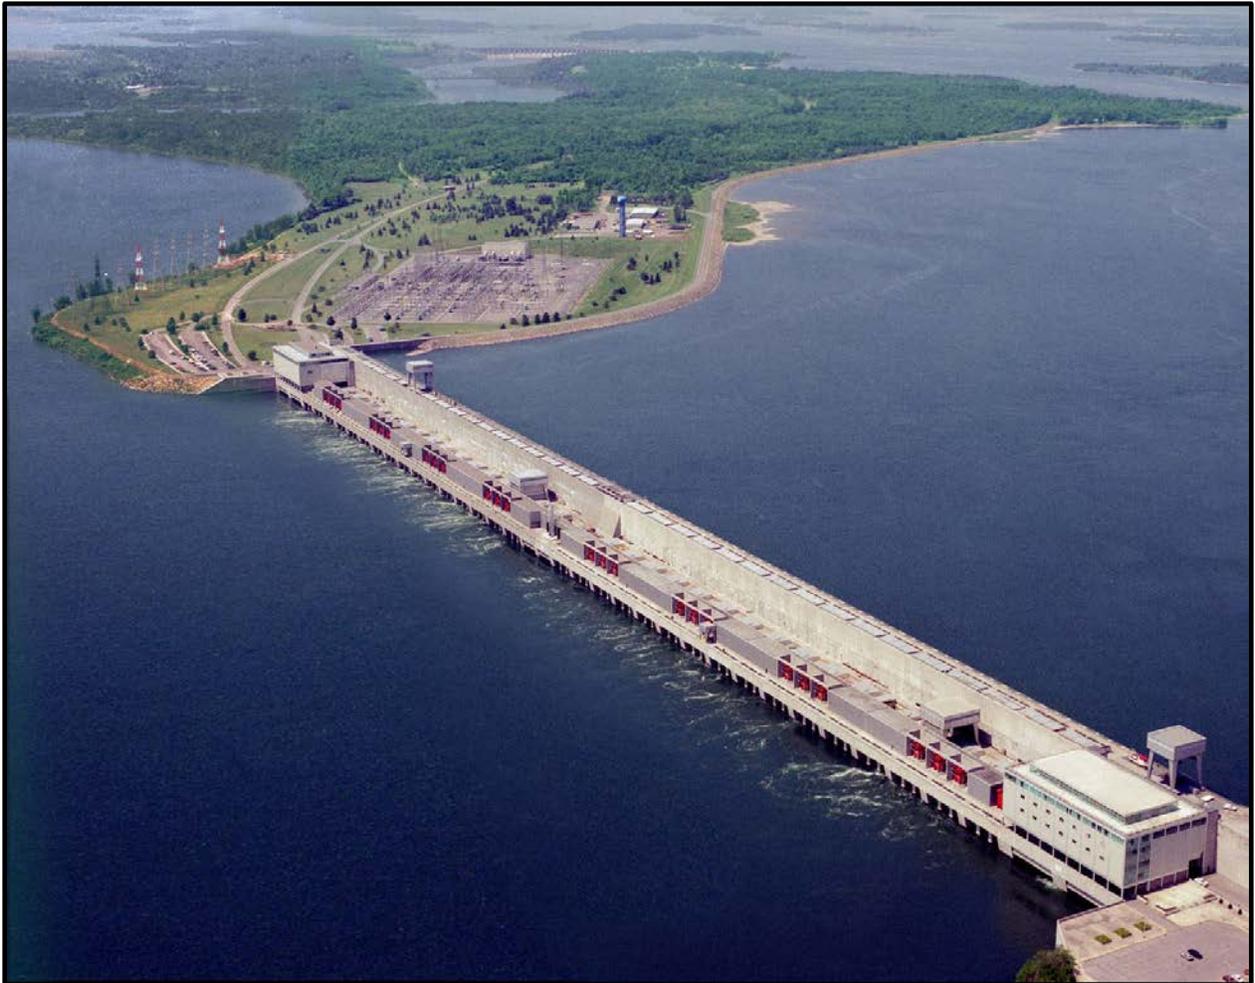
The Moses-Saunders facility (Figure 5-1) was run at capacity for much of 2017, and the Long Sault Dam spillway (Figure 5-2) was employed from 17 May to 1 September, 7 September, 19 to

Figure 5-1: Moses-Saunders Dam. Photo Credit: ILOSLRB.

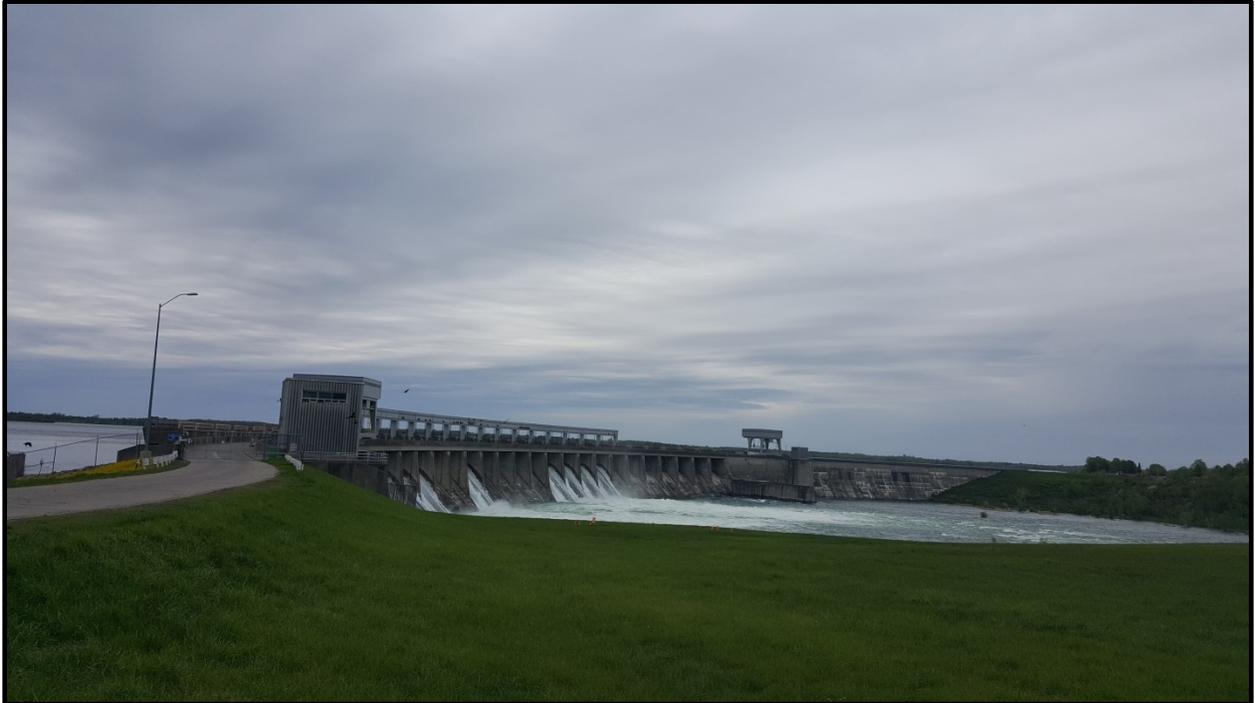
22 September, 27 September to 6 October, and 8 to 31 October, with daily mean spillage rates as high as almost 2,600 m³/s (91,800 ft³/s) (on 15 October; this spill equated to approximately 520 MW of potential lost production, or just over ¼ of the rated capacity of Moses-Saunders generating station).

Figure 5-2: Long Sault Dam, May 21, 2017. Photo credit: NYPA.

during final raising of the gates and debris removal operations lasting until 30 May) to adjust the gate settings and prevent flooding on Lake St. Lawrence. Two to ten gates at Long Sault Dam were partially opened from 17 May to 31 August to spill the amounts of the total Lake Ontario outflows that exceeded the capacity of the Moses-Saunders Dam. The total amount of water spilled during this period and lost to electrical power generation reached a maximum weekly average of 1,270 m³/s (44,800 cfs) during the week ending 24 May and equated to nearly 166 billion cubic meters (almost 6 trillion cubic feet) of water. The power entities also spilled various amounts of water at Long Sault Dam occasionally during September through December according to their ongoing maintenance requirements.

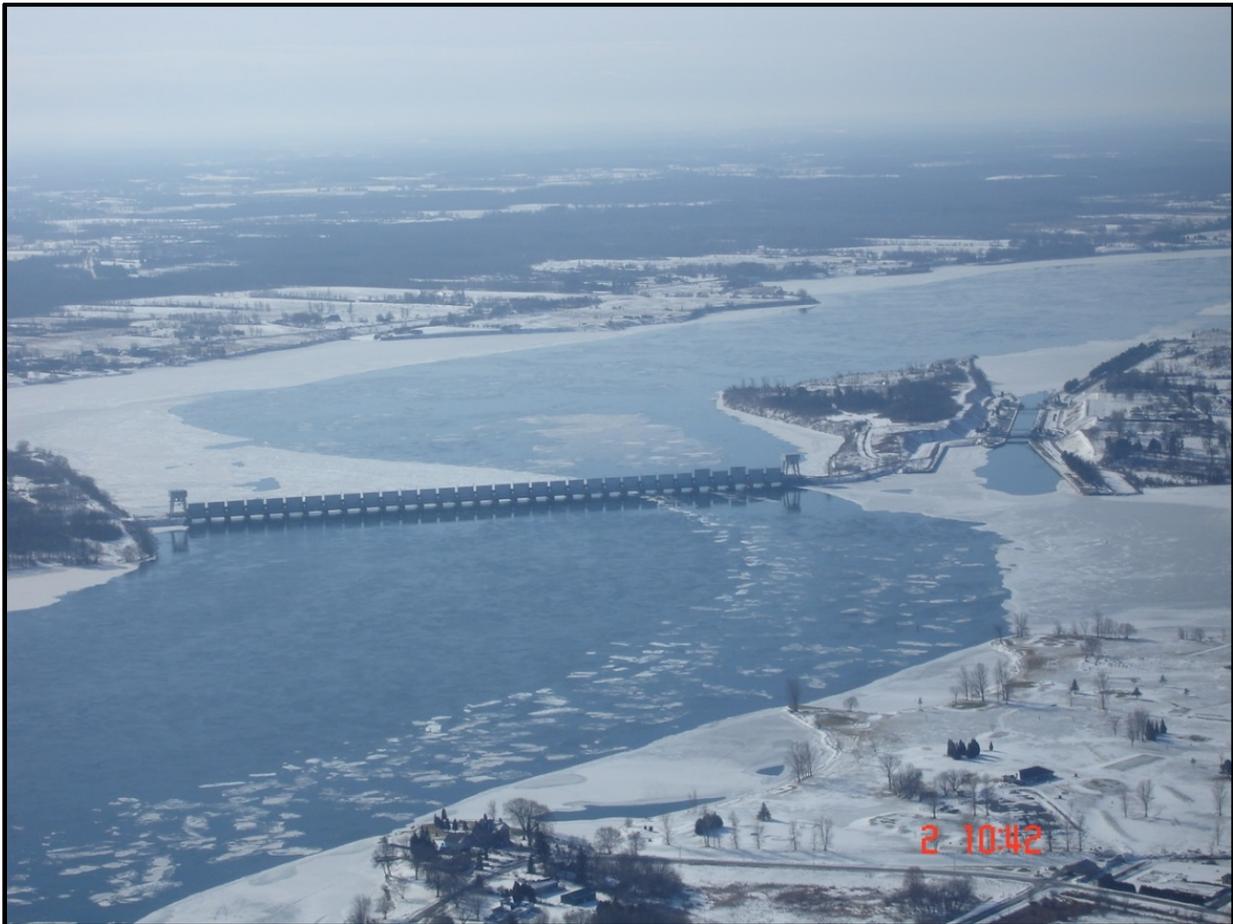
Figure 5-3: Iroquois Dam in winter. Photo credit: St. Lawrence Seaway Management Corporation.

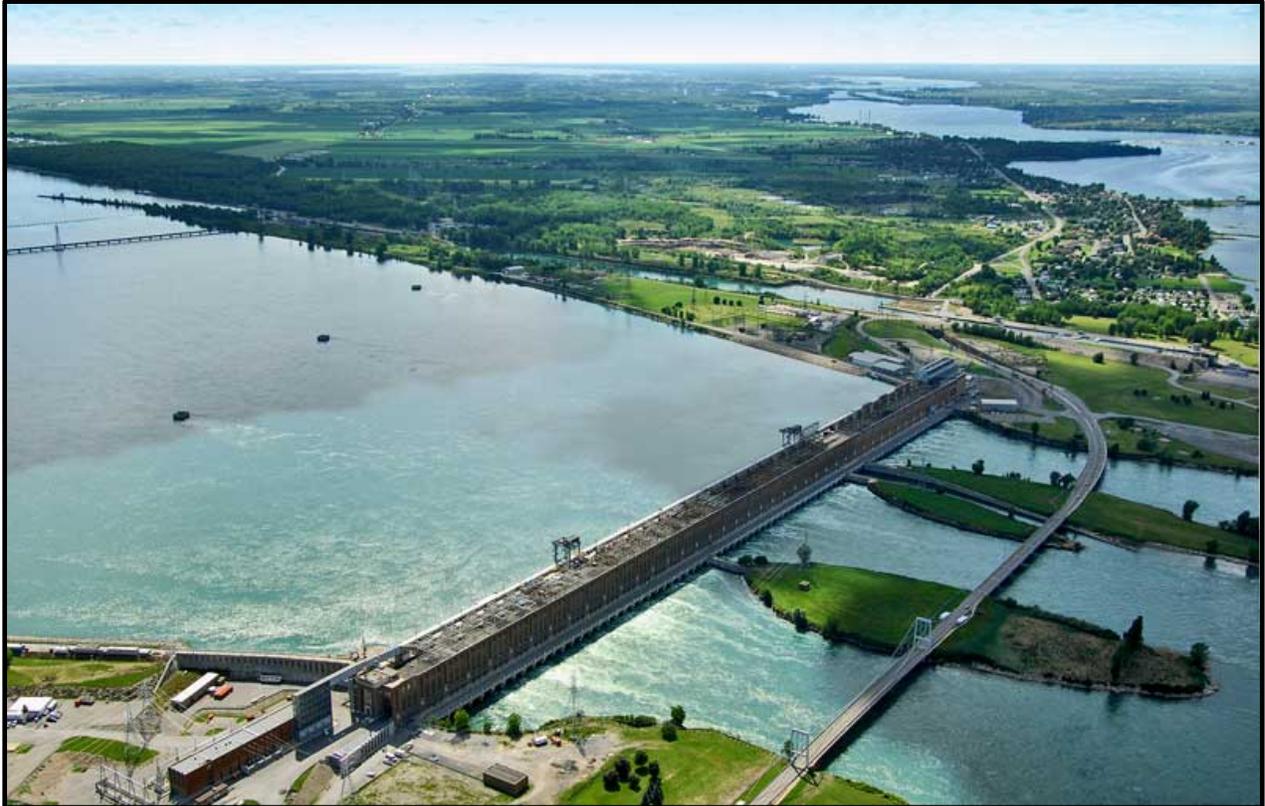
Hydro-Quebec (H-Q) reported having a challenging year, especially during ice management periods at the beginning and end of 2017 as well as during the Ottawa River flood period. Ice management challenges in 2017 included broken booms (at Autoroute 30 bridge and at km 10), anchor ice buildup, frozen control gates, as well as active formation occurring while the Seaway remained operational. The main booms ("A" and "G") in the International Rapids Section remained open until 10 January 2018 following an 11-day delay in the Seaway season closing at the end of the year, and an extremely frigid period in December. H-Q finds that Plan 2014 brings improvements in terms of flexibility with regards to setting flows during the ice season. H-Q also appreciates the excellent collaboration with the Canadian Regulation Representative team during the Ottawa River spring peak outflow period. Collaboration between the ILOSLRB and the Ottawa River Regulation and Planning Board was also appreciated. H-Q appreciated the choice of a constant (10,400 m³/s) (367,000 ft³/s) flowrate from Lake Ontario during the height of the flood, as it limited the number of operational maneuvers required at various control structures operated by the entity such as the Beauharnois/Les Cèdres complex (Figure 5-4).

Figure 5-4: Beauharnois/Les Cèdres Complex of Hydro-Quebec. Photo credit: Hydro-Quebec

Flowrates were maintained below the overall capacity of H-Q's complex, but still resulted in significant local impacts, including significant spill and the impact of high velocities on the natural bed of the river to the north of the Beauharnois Canal. Valleyfield Beach, in the St. Timothy Basin, was closed for the entire season. H-Q's booms were damaged at Ile-Juillet dam, requiring enhanced communications with the public regarding safe use of nearby waterbodies. Work at Ile-Juillet dam was deferred for two months (to ensure adequate operational capacity given the potential for even higher flows). That said, there were no reports of major impacts on residents as a result of H-Q operations in the area between Lake St. Francis and Lake Saint Louis.

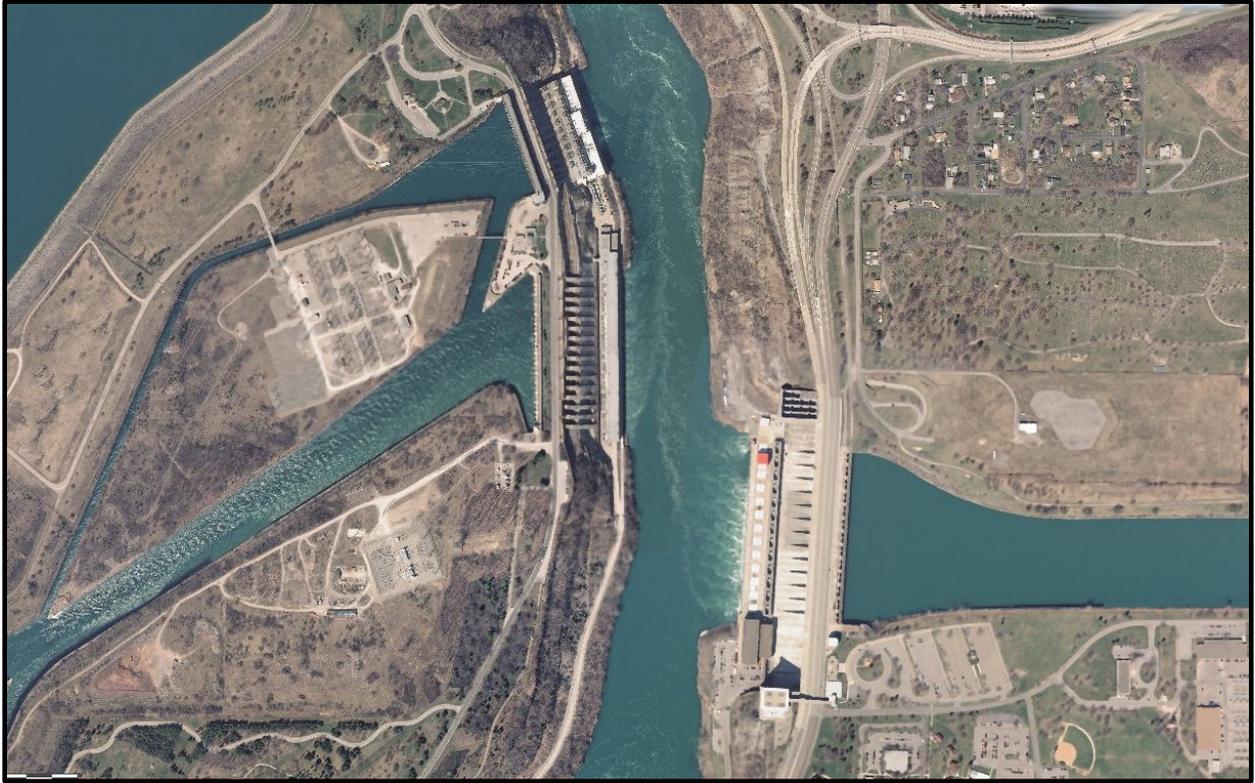
NYPA and OPG share the same dam and each has an equal number of turbines. A NYPA expert approved adopting the OPG model for energy production. The tailwater elevations at the Niagara River power plants are related to the levels of Lake Ontario, so a regulation plan that increases Lake Ontario levels may increase energy production at Moses-Saunders, but reduce power production at Niagara Falls. So, for the purposes of Lake Ontario-St. Lawrence River plan evaluations, model estimates of energy produced at Niagara Falls are included. Higher Lake Ontario levels may increase the water levels above Moses-Saunders, but that elevation is also strongly influenced by the flow through the dam.

Figure 5-5: OPG and NYPA generating stations on the Niagara River. Sir Adam Beck Dam is on the left and Robert Moses Dam is on the right. Photo credit: Google Photos.

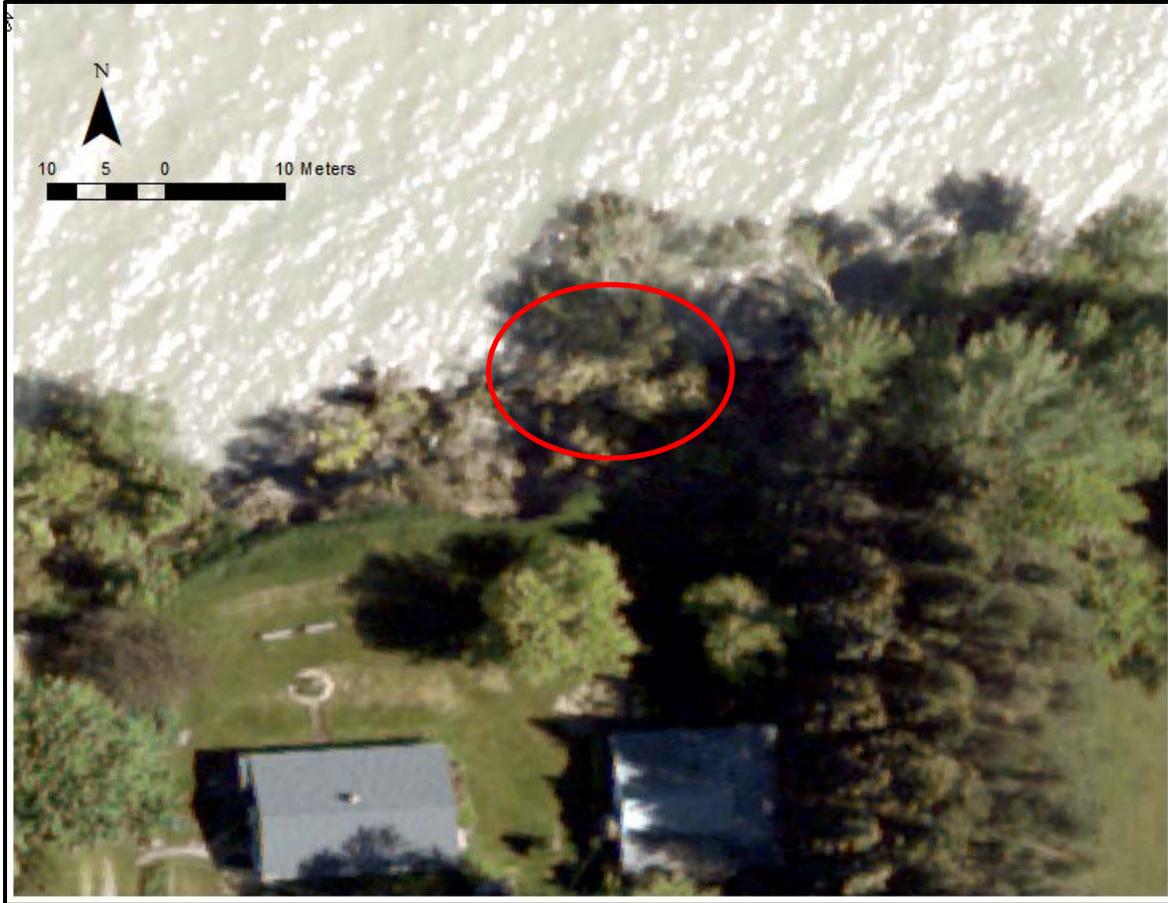
Figure 6-10: Example of shoreline erosion observed for a specific property in Niagara County. Note the trees and vegetation in the water. (Source: USACE Aerial Imagery – June 2, 2017).

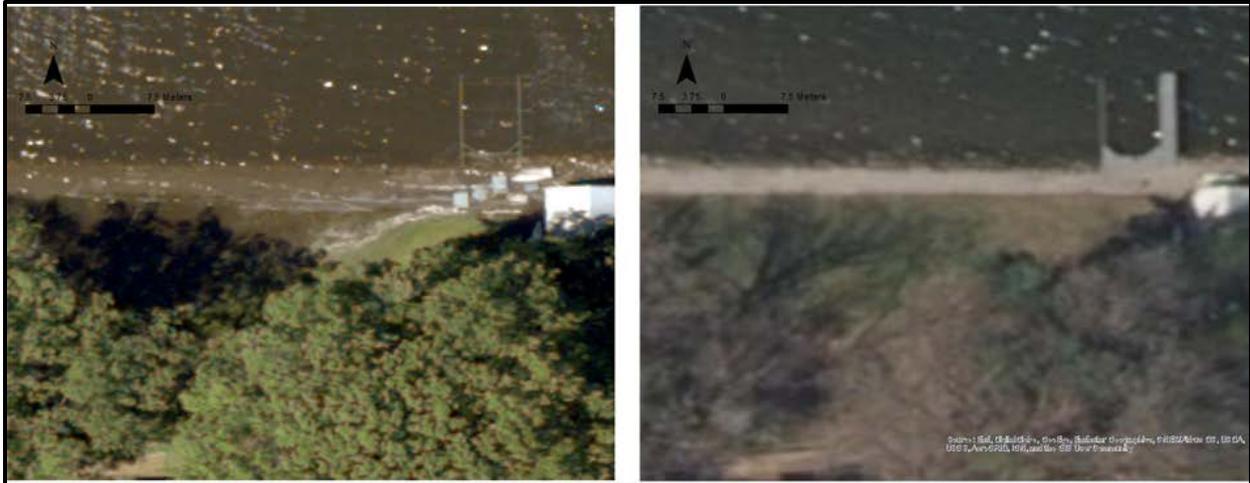
Figure 6-16 illustrates the type and quantity of property impacts in Monroe, Wayne and Cayuga counties as identified through the imagery and Figure 6-17 and 6-18 are examples from the imagery to illustrate what was observed. In this region, there was a significant amount of landscaping, lawns and docks that were impacted. Property impacts to building foundations and vegetation and trees were also commonly impacted.

Figure 6-17: Example of flooding of lawn/landscaping in Irondequilt Bay, Monroe County on June 3, 2017 (left) and April 15, 2015 (right). Photo Credit: USACE Aerial Imagery – June 3, 2017, and ESRI – April 15, 2015.

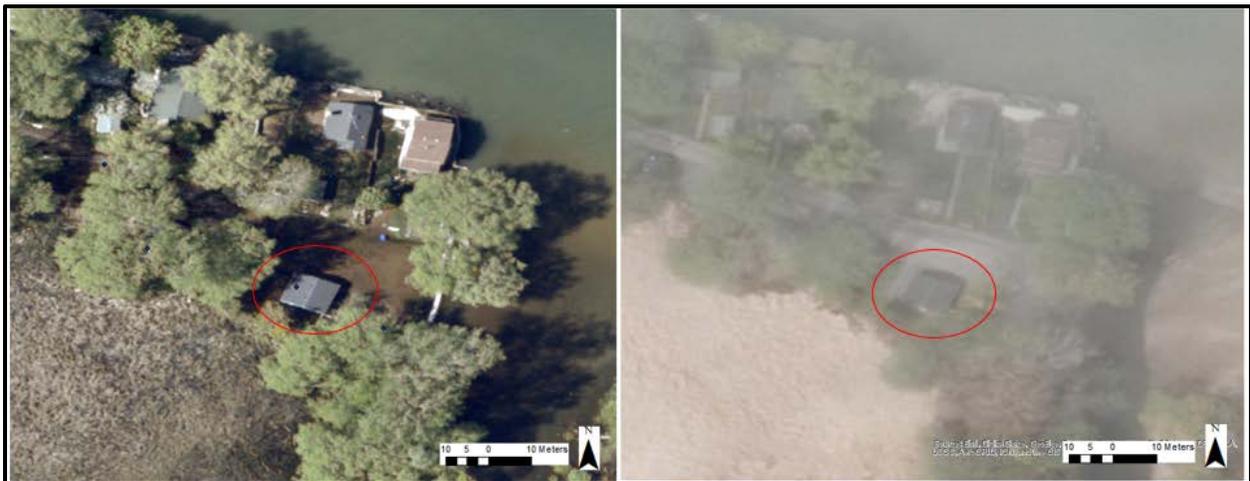
Figure 6-18: Example of flooding of residential building foundation in Monroe County, June 3, 2017 (left) and April 15, 2015 (right). Photo Credit: USACE Aerial Imagery – June 24, 2017, ESRI Imagery – April 15, 2015.

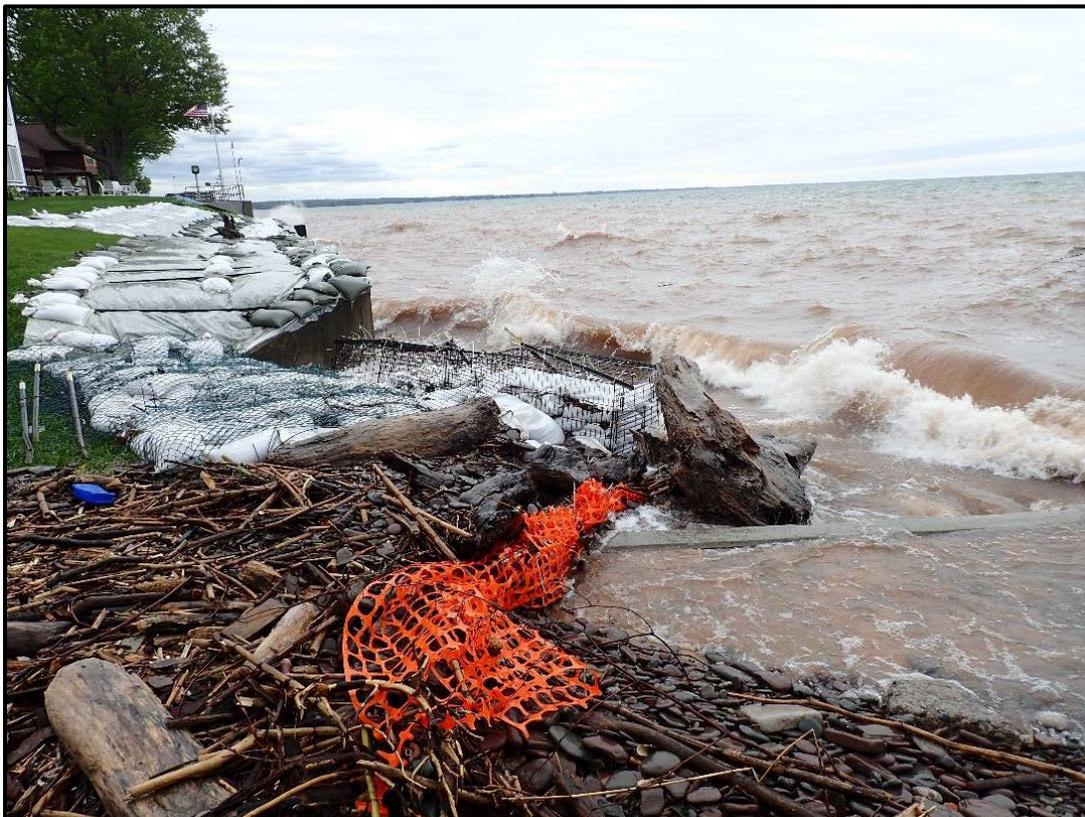
Figure 6-21: Sandbag protection at Recreation Association in Webster, NY on 19 May, 2017 (Source: USACE Buffalo, 2017)

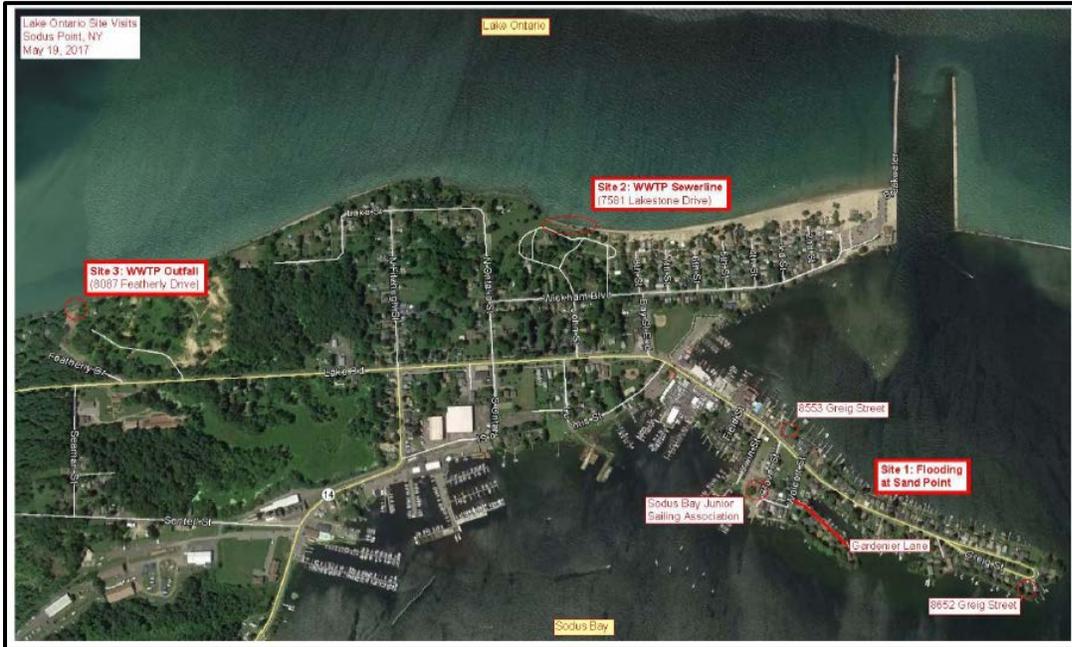
Figure 6-22: Impacts observed at Sodus Point (Source: USACE Buffalo, 2017)

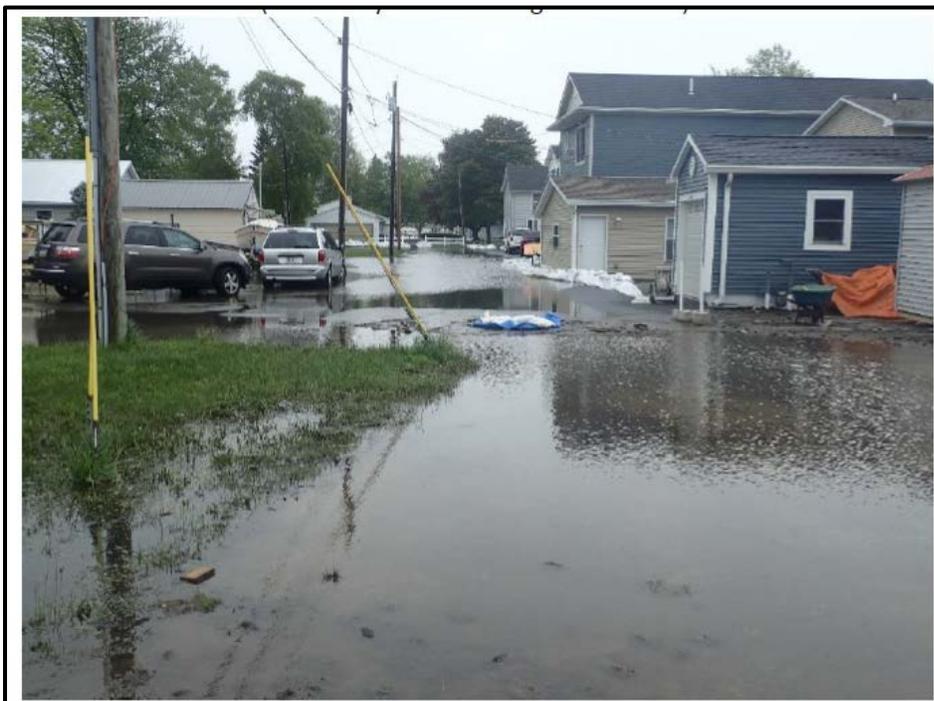
Figure 6-23: Interior flooding along Gardenier Lane in Sodus Point, NY, 19 May, 2017 (Source: USACE Buffalo, 2017)

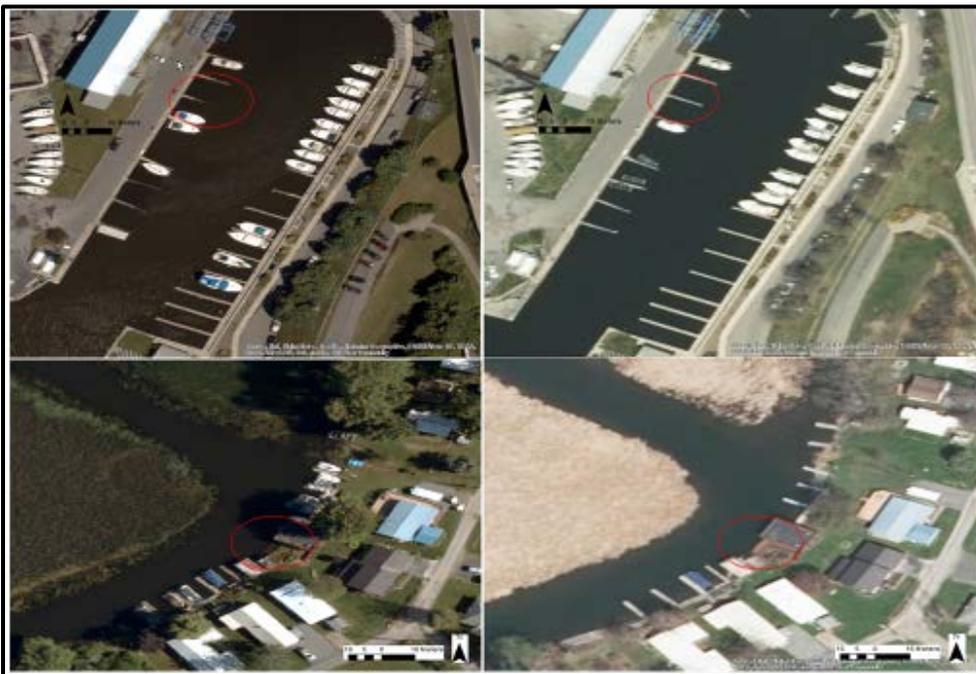
Figure 6-25: Example of flooding impacts to a public marina in Oswego County on June 24, 2017 (top left) and April 15, 2015 (top right), and to a private dock in Oswego County on June 24, 2017 (bottom left) and April, 15, 2015 (bottom right). Photo Credit: USACE Aerial Imagery – June 24, 2017, ESRI Imagery – April 15, 2015.

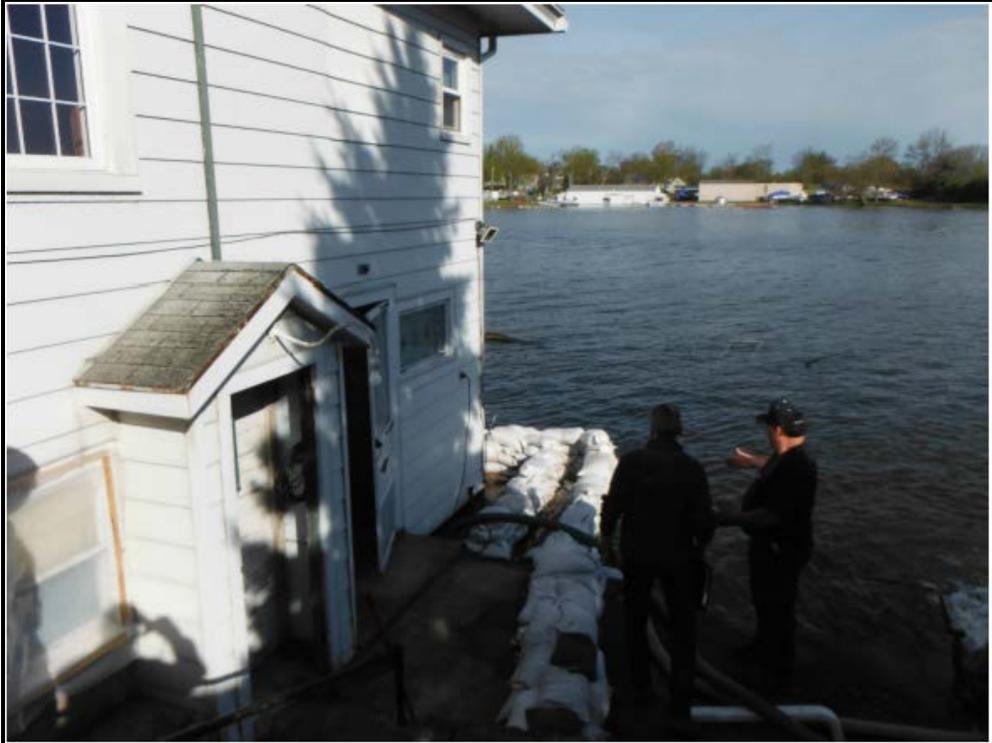
Figure 6-28: Residential flooding in Lyme, NY, May 16, 2017 (Source: USACE Buffalo, 2017)

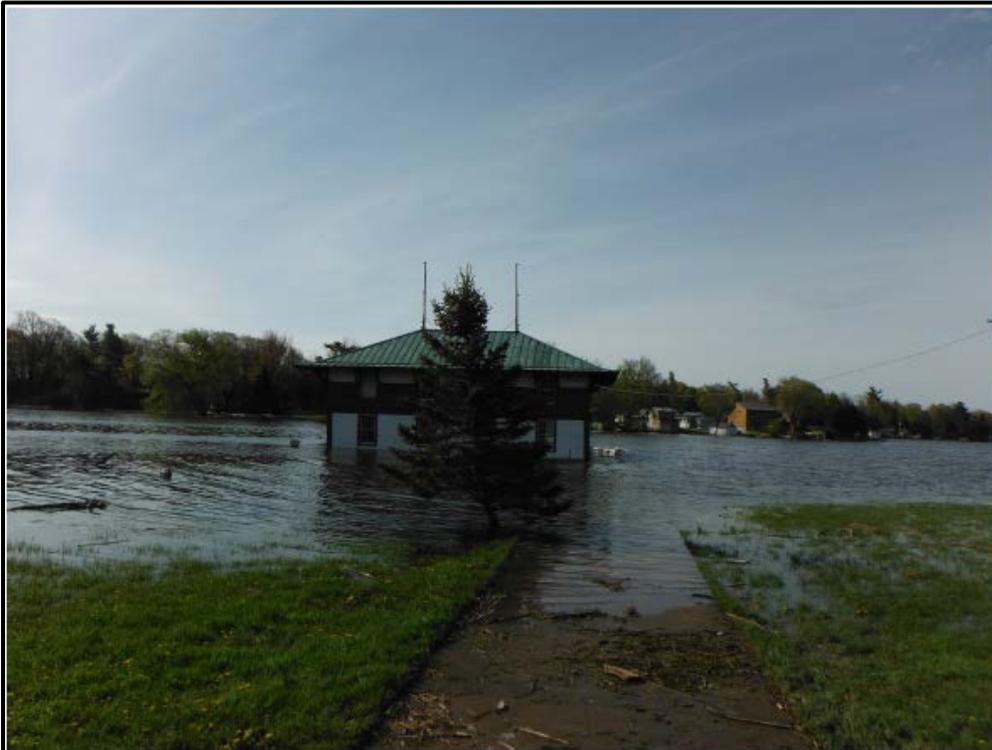
In Lyme, NY, impacts to several residential homes were observed on South Shore Road and Water Street (Figure 6-28). Adaptive actions to protect private residences included sandbagging and pumping of low-lying areas. A historic boat house was inundated and sandbags were replaced in an attempt to prevent further damage due to wave action (Figure 6-29). Along County Route 57, wave run-up was inundating the road and eroding the isthmus. Erosion along Beach Road was observed due to wave run-up. At Long Point State Park, the boat launch and dock area were closed due to flooding (Figure 6-30).

Figure 6-29: Flooding of National Historic Registry Boathouse, Lyme, NY, May 16, 2017 (Source: USACE Buffalo, 2017)

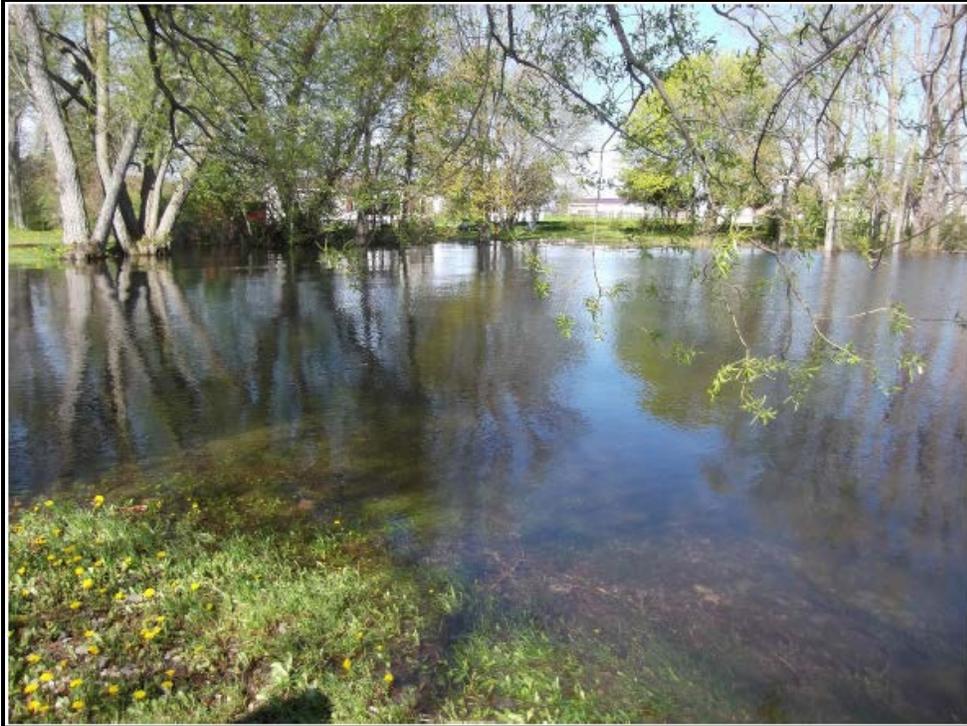
Figure 6-30: Flooding in Long Point State Park, Lyme, NY, May 16, 2017 (Source: USACE Buffalo, 2017)

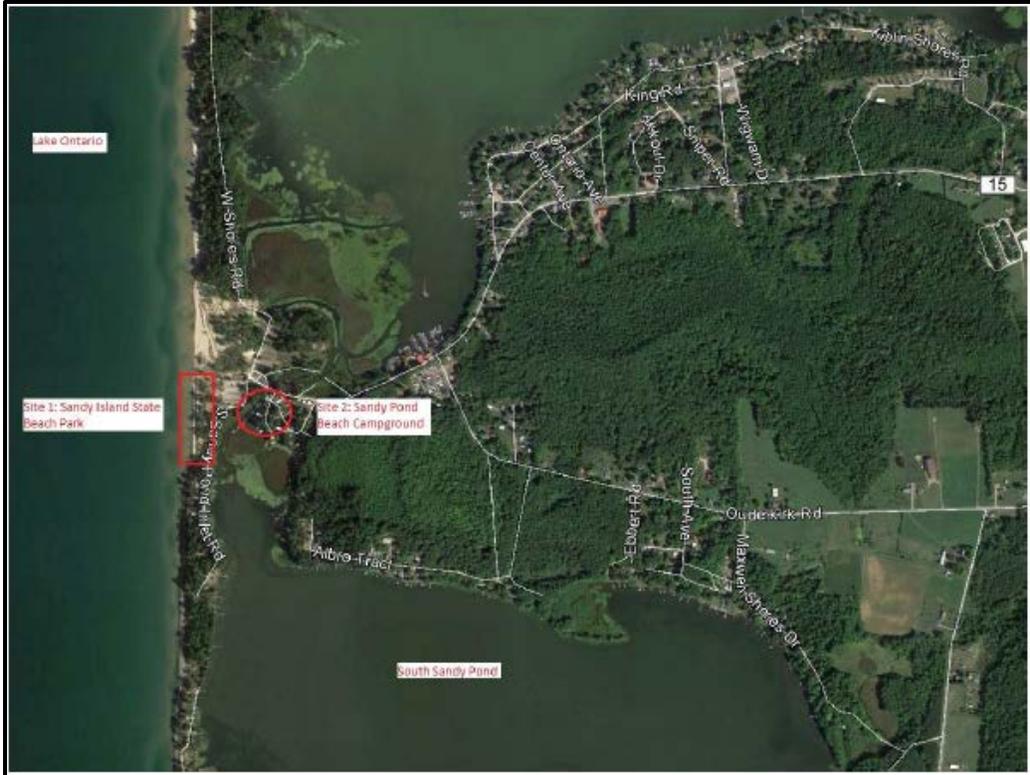
In Sandy Creek, NY a large portion of a sand dune and adjacent beach was lost to high static water levels and wave action at Sandy Island Beach State Park (Figure 6-31). It was noted that littoral drift is rare in this area. At Sandy Pond Beach Campground, 12 residences were experiencing several inches of first floor flooding (Figure 6-32). As noted in the municipal and industrial section earlier (Section 3), all of these residences' septic systems were flooded, rendering all sanitary facilities inoperable. Adaptive actions included installing a line of sandbag defense around the perimeter of the campground. The sandbag line of protection lacked proper construction techniques and therefore proved inadequate in providing the expected protection.

Figure 6-31: Sandy Creek overview of impacted areas (Source: USACE Buffalo, 2017)
