Great Lakes - St. Lawrence River Adaptive Management (GLAM) Committee

Annex 1:

Supplementary impact assessment information for Lake Ontario and the St. Lawrence River

November 26, 2018

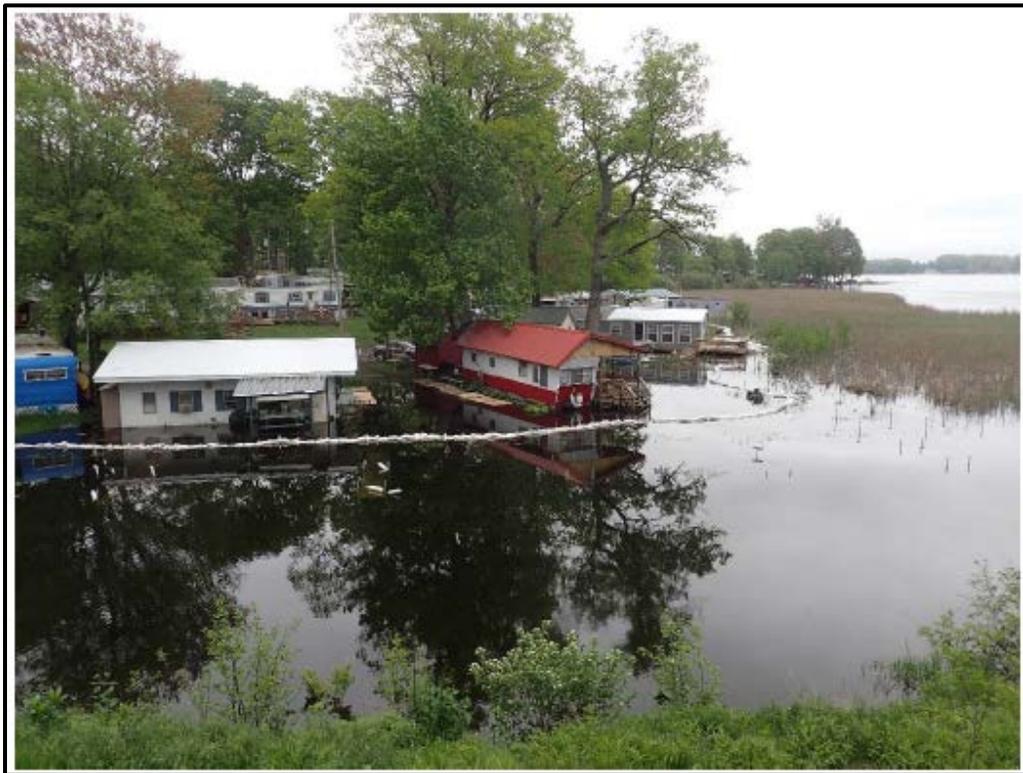
In Sandy Creek, NY a large portion of a sand dune and adjacent beach was lost to high static water levels and wave action at Sandy Island Beach State Park (Figure 6-31). It was noted that littoral drift is rare in this area. At Sandy Pond Beach Campground, 12 residences were experiencing several inches of first floor flooding (Figure 6-32). As noted in the municipal and industrial section earlier (Section 3), all of these residences' septic systems were flooded, rendering all sanitary facilities inoperable. Adaptive actions included installing a line of sandbag defense around the perimeter of the campground. The sandbag line of protection lacked proper construction techniques and therefore proved inadequate in providing the expected protection.

Figure 6-32: Sandbag line of protection at Sandy Pond Campground on May 26, 2017 (Source: USACE Buffalo, 2017)

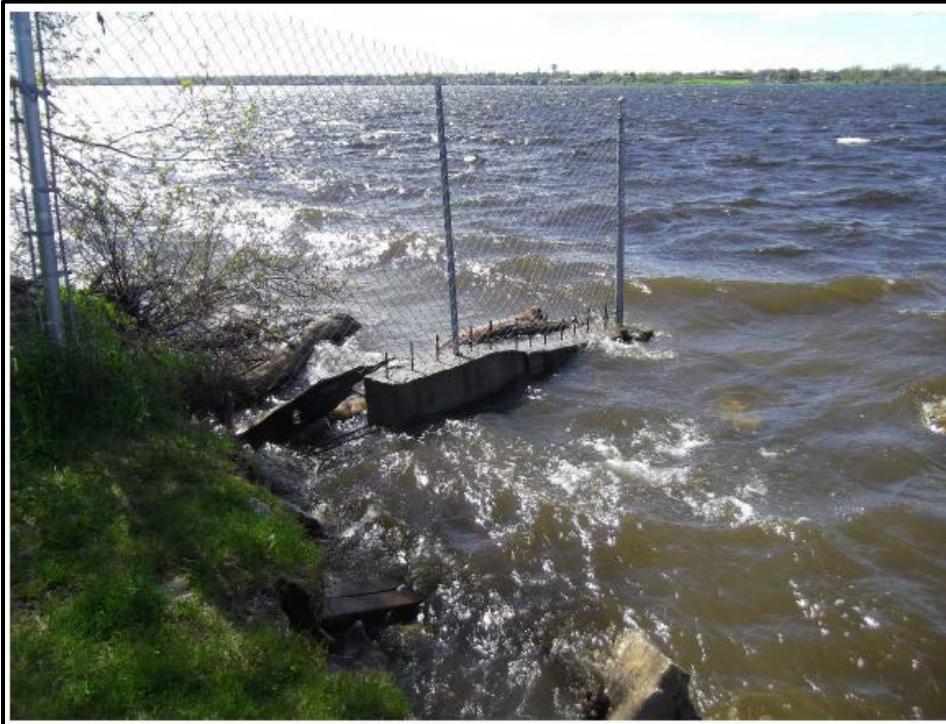
Figure 6-33: Shoreline erosion by boat launch in Ogdensburg, NY on May 15, 2017 (Source: USACE Buffalo, 2017)

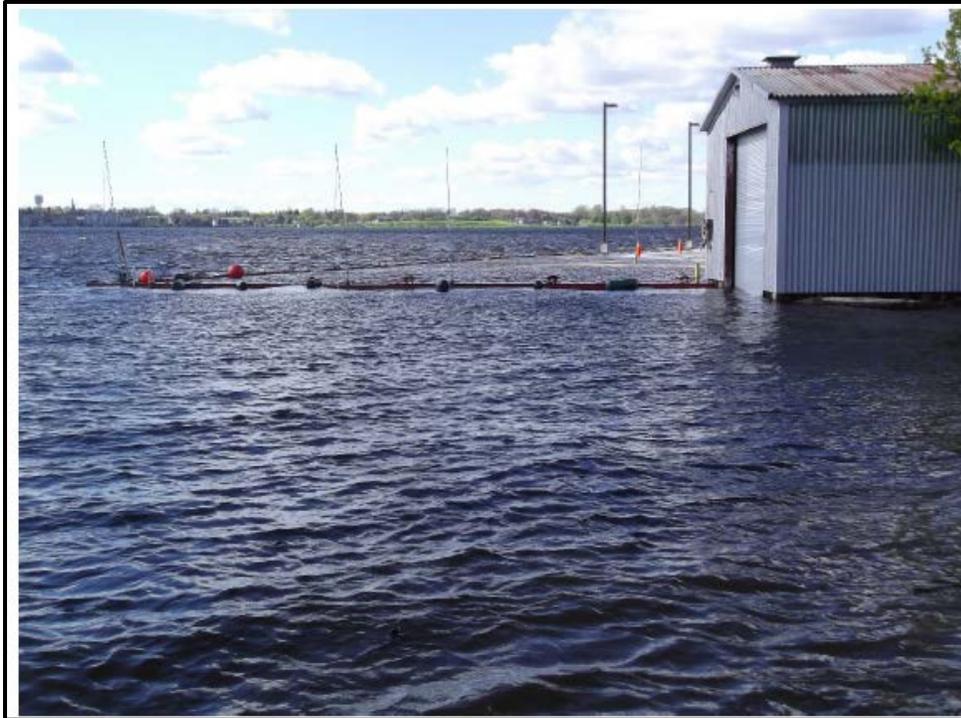
In Ogdensburg, NY, erosion was observed at the Patterson street boat launch (Figure 6-33). Impacts at Morisette Park included erosion to parts of marina infrastructure and flooding of access paths for shoreline features. The US Customs and Border Protection facility helicopter pad and parking lot was inundated (Figure 6-34).

Figure 6-34: Inundation of US Border Protection Helipad, Ogdensburg, NY on May 15, 2017 (Source: USACE Buffalo, 2017)

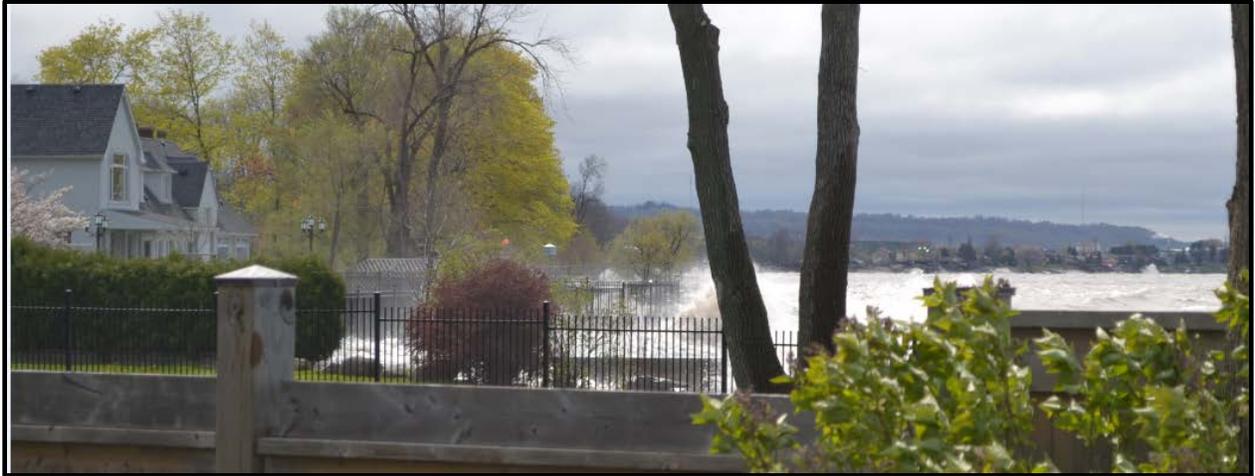
Wind and storm events also caused problems from Niagara through to the Region of Peel due to wave action. Wave spray and wave uprush drove water up and onto shoreline properties leading to significant ponding of water around buildings. This occurred in portions of the Stoney Creek shoreline in the City of Hamilton (Figure 6-39). Storm events also caused other challenges. For example, a June 19, 2017 article in NiagaraThisWeek.com noted that voluntary evacuation notices were periodically required for some locations in the Town of Lincoln where wave action was contributing to short term access issues along shoreline roads (<https://www.niagarathisweek.com/news-story/7379312-lincoln-still-recovering-from-spring-storms/>). Flooding of public park lands and other public infrastructure was observed in many locations along the shoreline. Access to Lakeside Park in Port Dalhousie was restricted for much of the summer and there were flooding problems along portions of Confederation Park in the City of Hamilton. In Oakville, particular problems were reported at Coronation Park causing damages and restricting access as well as Carrington Promenade, Gairlock Gardens, Dingle Park, and Shoreline Park (City of Oakville, 2017) while in Mississauga, St. Lawrence Park, Marina Park, J.J. Plaus Park, and J.C. Saddington Park were among the most heavily impacted (City of Mississauga, 2017). In Burlington, the shoreline section of Burlington Beachway Park was closed from May 17, 2017 due to a combination of high water levels submerging the beach and erosion concerns.

Figure 6-39: Wave action along the City of Hamilton shoreline, April 30, 2017. Photo credit: ECCC.

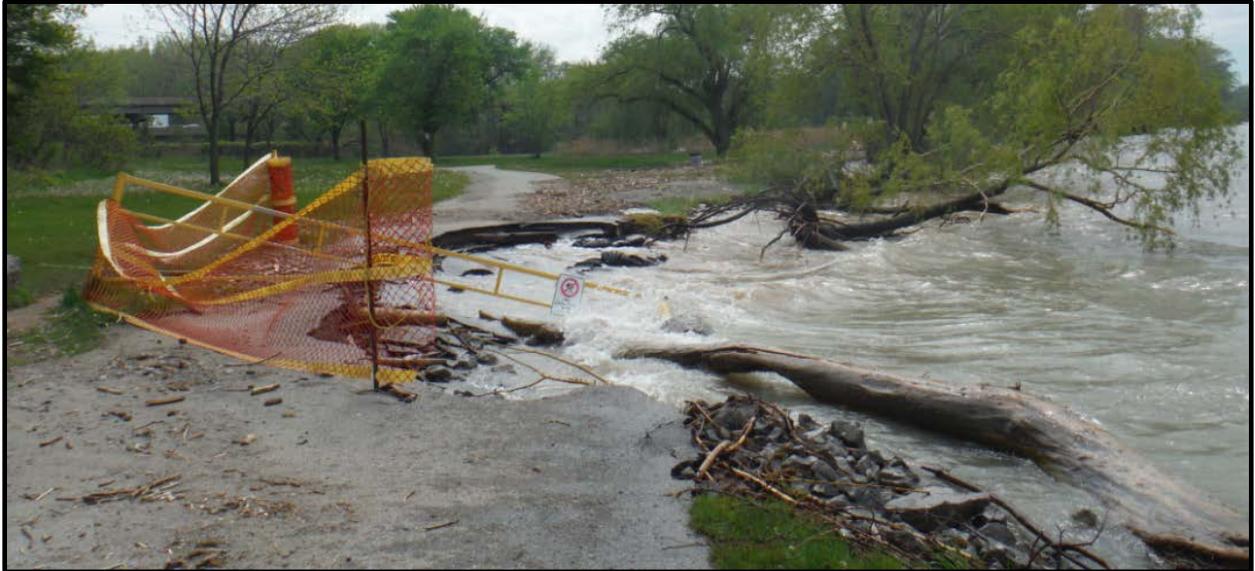
Figure 6-40: Example of shoreline erosion at Charles Daley Park within the Region of Niagara (photo taken May 24th, 2017). Photo credit: ECCC.

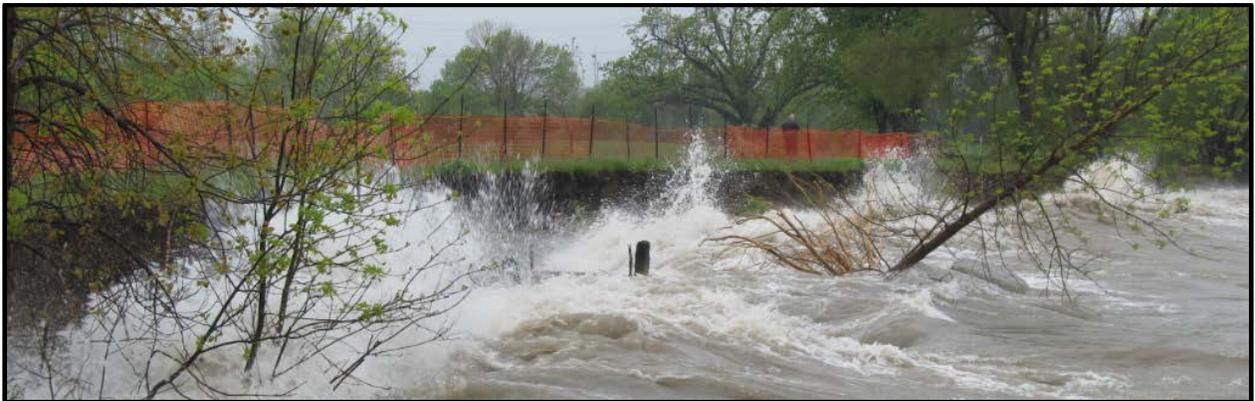
Figure 6-41: Example of shoreline erosion at Confederation Beach Park, City of Hamilton, May 17, 2017. Photo credit: City of Hamilton.

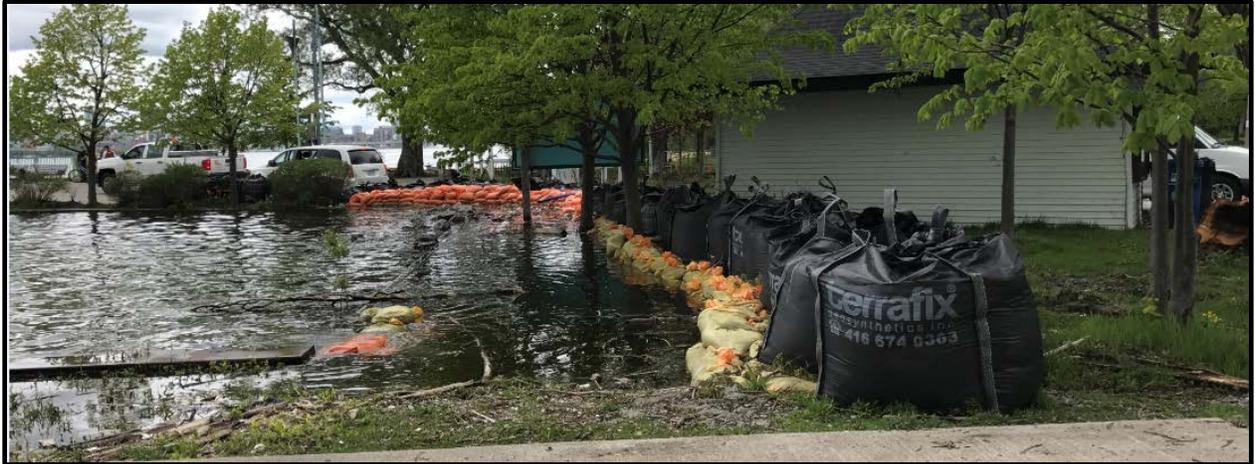
Figure 6-43: Sandbagging on Toronto Island, May 26, 2017. Photo credit: ©Toronto and Region Conservation (TRCA).

lots and flooding crawl spaces. Access and egress were a problem in the area due to inundation of parts of Cedar Crest Beach and West Beach roads on a number of occasions. As with the Toronto Island example, sandbagging efforts did appear to provide protection in some cases following the initial storm events in late April and early May. Figure 6-45 illustrates the difference in conditions at the site between a stormy day with onshore winds in late May (lakewide water level of 75.88 m (248.95 ft)) and a calmer day in early June with a higher lakewide water level of 75.81 m (248.72 ft) but little wind setup or wave action.

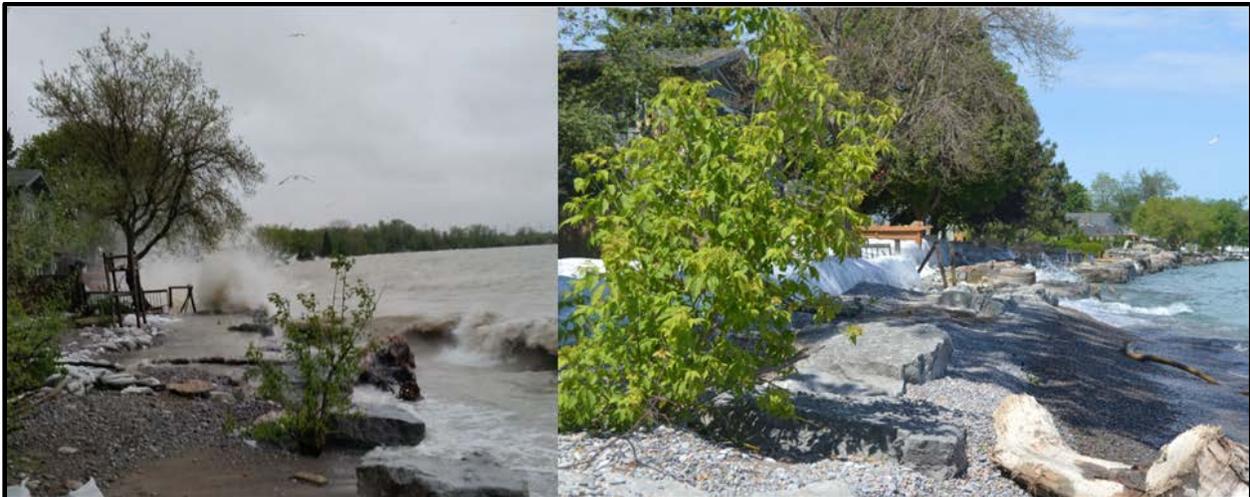
Figure 6-45: Cedar Crest Beach Road. The photo on the left was taken May 25, 2017. Photo credit: Clarington Fire and Emergency Services. The photo on the right was taken June 14, 2017. Photo credit: ECCC.

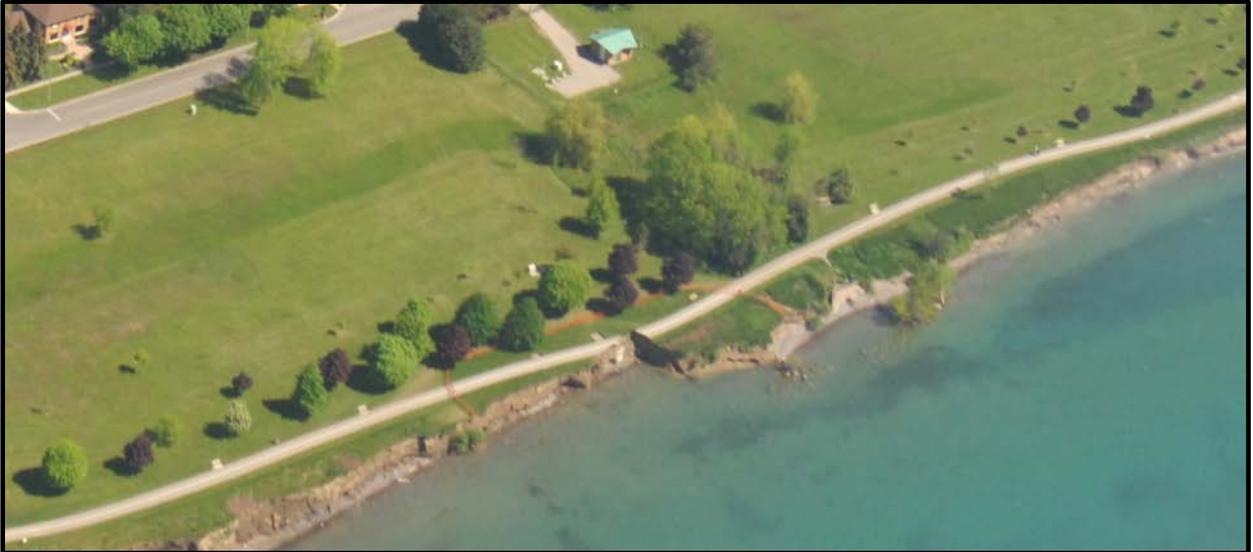
Figure 6-47: Example of shoreline erosion and impacts to trail in Ajax Ontario, June 8, 2017. Photo credit: Transport Canada National Aerial Surveillance Program.

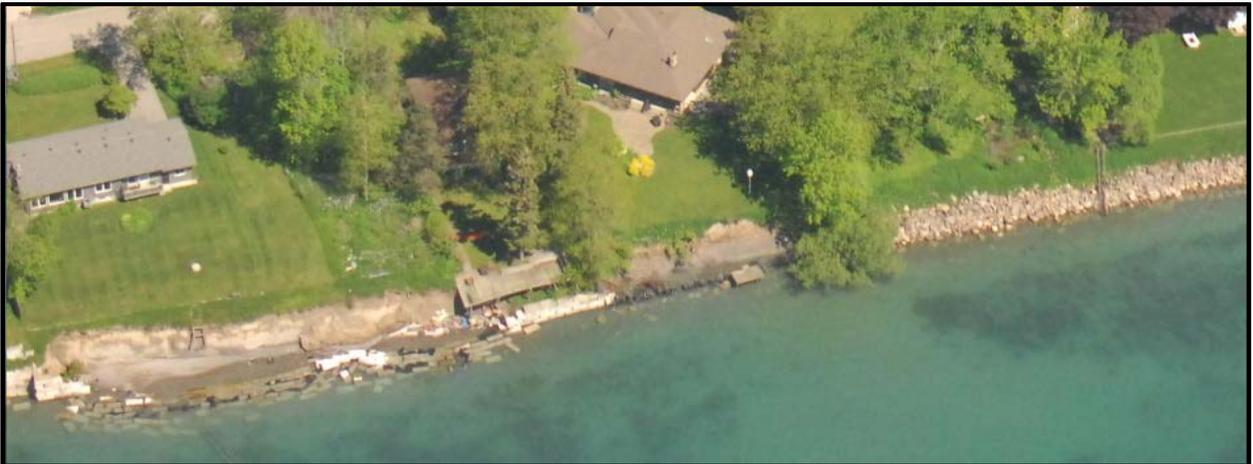
Figure 6-48: Example of collapsed shoreline protection in Ajax Ontario, June 8, 2017. Photo credit: Transport Canada National Aerial Surveillance Program.

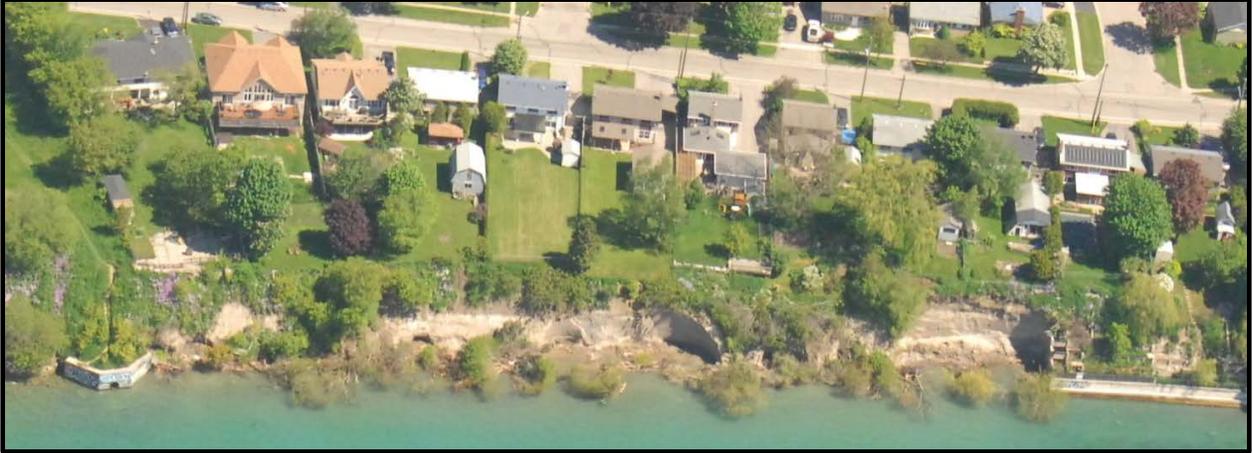
Figure 6-49: Example of shoreline erosion in Oshawa, Ontario, June 8, 2017. Photo credit: Transport Canada National Aerial Surveillance Program.

Residential flooding due to high water levels was not commonly reported in other portions of Durham Region but other impacts were observed, particularly due to erosion. For example, the City of Oshawa has estimated \$320,000 (as of June 16, 2017 staff report) for repairs to damaged municipal shoreline infrastructure including shoreline breakwall repairs and re-armouring, replacing fencing within Lakeview Park and beach material replacement and re-grading. Expenditures related to repair and restoration of the pier are not currently available (City of Oshawa, 2017). Flooding and erosion issues along waterfront parks and trails were also reported in Whitby, Ajax and Pickering although specifics and cost estimates are not currently available. A review of the oblique imagery and other imagery indicated a variety of impacts for Durham Region, such as examples where shoreline erosion and changes occurred during 2017 (Figure 6-47 through Figure 6-50). Most of the erosion impacts reported in the shoreline questionnaire were related to vegetation loss and beach impacts (Figure 6-51).

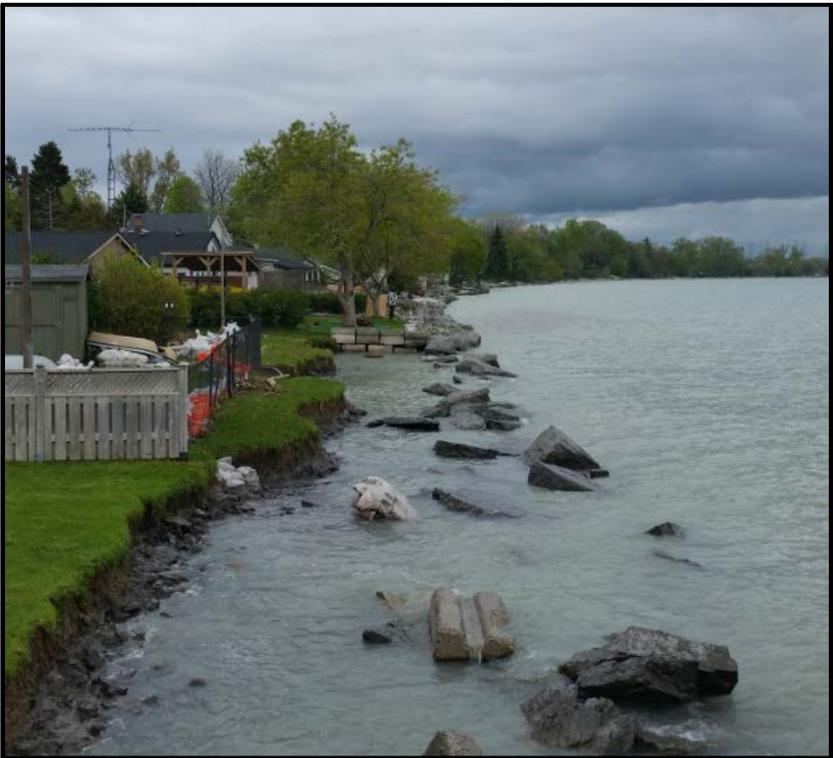
Figure 6-50: Shoreline erosion behind failed shoreline protection in Municipality of Clarington, May 26, 2017. Photo credit: Municipality of Clarington Fire and Emergency Services.

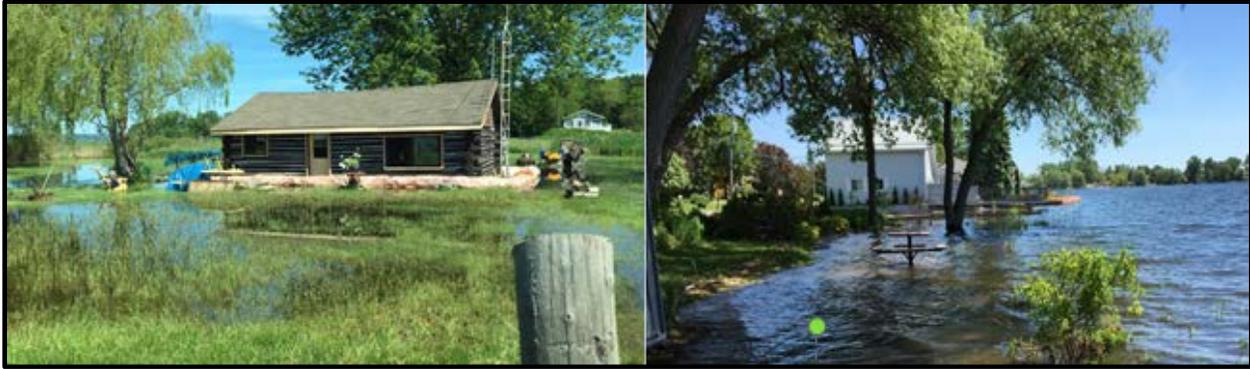
Figure 6-52: Photographs of flooding impacts in the Brighton area, June 14, 2017. Photo credit: ECCC.

Further east in Northumberland County, which includes the communities of Port Hope, Cobourg, and Brighton, residential flooding was most commonly reported at the eastern end of the county including in the Brighton area (see map in Figure 6-8). Site visits by support staff for the GLAM Committee in early June illustrated examples of imminent and direct impacts to residences in the Brighton area (Figure 6-52). A review of available oblique imagery for much of the Northumberland shoreline identified 11 examples of flooding under static water level conditions. However, the imagery did not have good quality or coverage in the most highly impacted areas of Brighton and Presqu'ile Bay, and Google Earth images were used to supplement in that area as updated images are available for the time period of interest. There were 37 responses (33 residential, four business) for the online self-reporting shoreline property owner questionnaire for Northumberland County. Of those responses, 30 identified some sort of flooding impact with the most commonly reported impact being to lawn/landscaping. Figure 6-53 shows the number of responses for the various categories identified in the online questionnaire. Outside of residential flooding, the town of Cobourg noted that high water levels caused problems and closures at various local beaches and the cancellation of some events (e.g. beach volleyball). Sandbagging was required to limit road flooding in a number of areas of Brighton, particularly the Gossport neighbourhood.

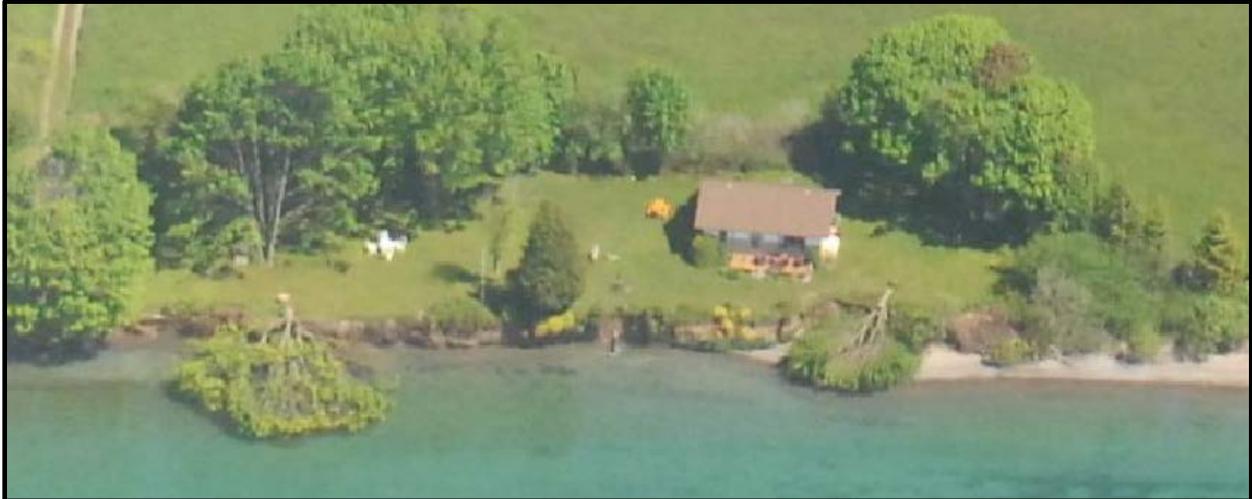
Figure 6-54: Example of shoreline erosion in Northumberland County, Ontario, June 8, 2017. Photo credit: Transport Canada National Aerial Surveillance Program.

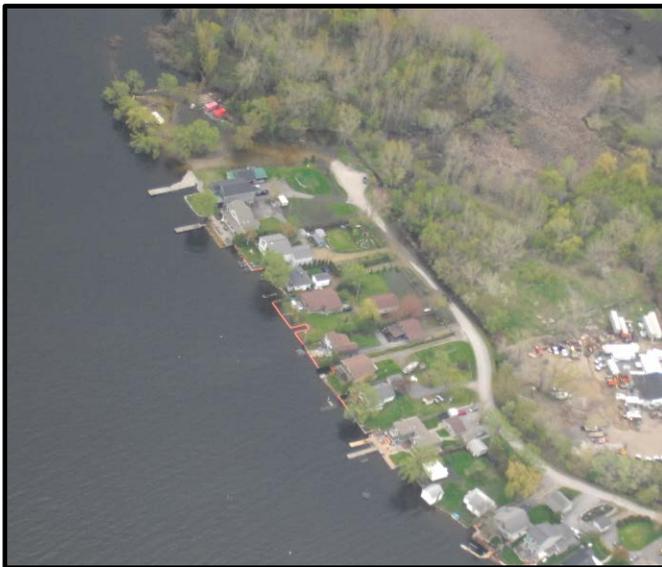
Figure 6-56: Example of shoreline flooding near Rossmore, Ontario. Photo credit: Transport Canada National Aerial Surveillance Program, May 14th, 2017.

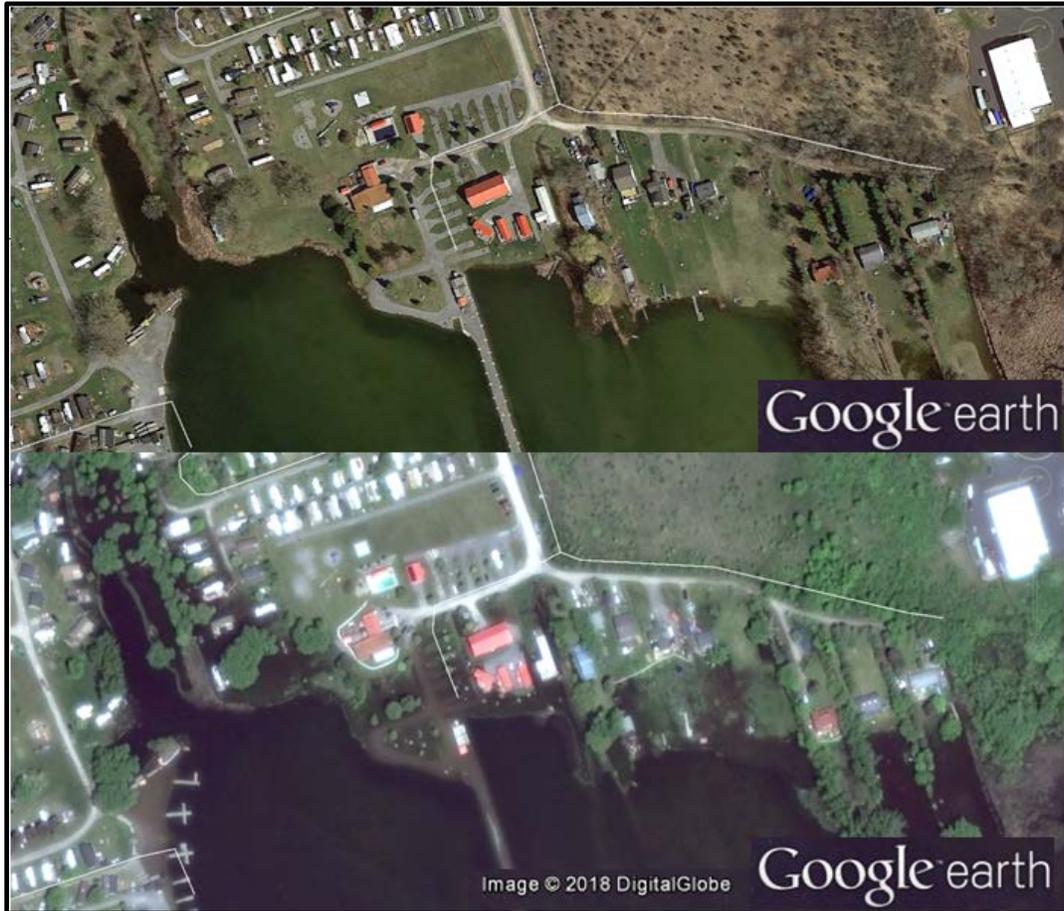
Figure 6-57: Comparison of April 17 and June 2 imagery in the Southwest area of Hastings County. Photo credit: Google maps.

workshop presentation). Despite the few examples of first floor flooding, it is clear that there were many situations where the static water level or the addition of wave action and storm surge put residential buildings at risk. Oblique imagery flown on June 14, 2017 illustrated a number of these situations. For example, Figure 6-56 illustrates a particularly low-lying section of shoreline in the Rossmore area with significant sandbagging and static water levels approaching a number of buildings. Figure 6-57 uses Google Earth imagery to illustrate the difference in shoreline inundation in a protected embayment near the south west end of Hastings County between April 17 and June 2, 2017.

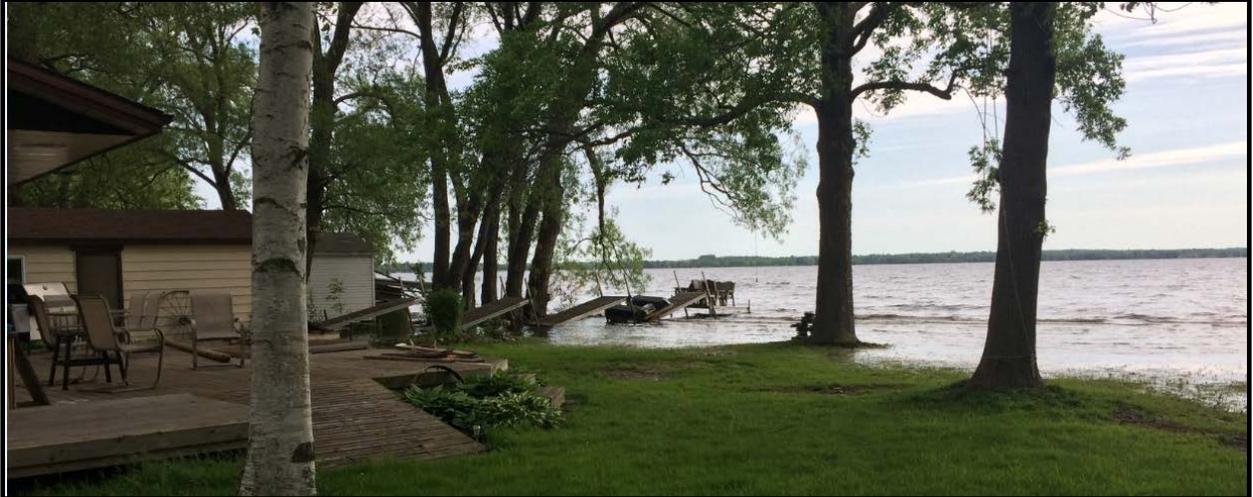
Figure 6-58: High water in the Consecon area of Prince Edward County, June 15, 2017. Photo credit: ECCC.

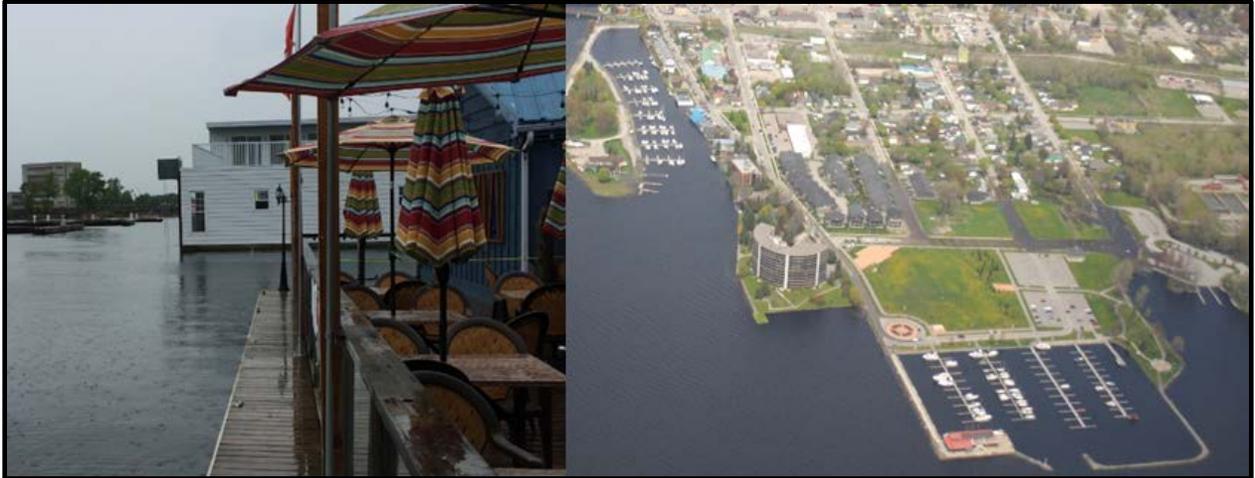
Figure 6-59: High water in the Belleville area of Hastings County, June 15, 2017 (left) and May 14, 2017 (right). Photo credit: ECCC, and Transport Canada National Aerial Surveillance Program, respectively.

In Hastings, the waterfront area of Belleville experienced a number of high water problems. A photo gallery of some of the municipal impacts are available through the City website (<http://belleville.ca/gallery/2017-flood>). As with many other areas of the Canadian shoreline, direct first floor flooding did not appear to be the primary problem, although there were some examples where businesses along the waterfront were significantly impacted by floodwaters (Figure 6-59). Flooding of roads and parkland was observed in a portion of the waterfront near downtown (see Figure 6-59) and required a response from the City to facilitate access for local residents by elevating some flooded roadways using gravel. Meanwhile, Lennox and Addington County reported various shoreline impacts totalling up to \$800,000 and were going to apply under the Municipal Disaster Recovery Assistance Program (Loyalist Township, 2017). Primary municipal impacts included damage to roadways and damage to existing retaining walls protecting the Fairfield water treatment plant. Cataraqui Region Conservation Authority staff noted flooding problems related to homes in both Hay Bay and Bath although a specific number of impacted properties is not currently available. Oblique photographs in those areas indicated at least a few locations that appeared particularly at risk, recognizing that it can be difficult to make a qualitative assessment of flood vulnerability from the images in some areas.

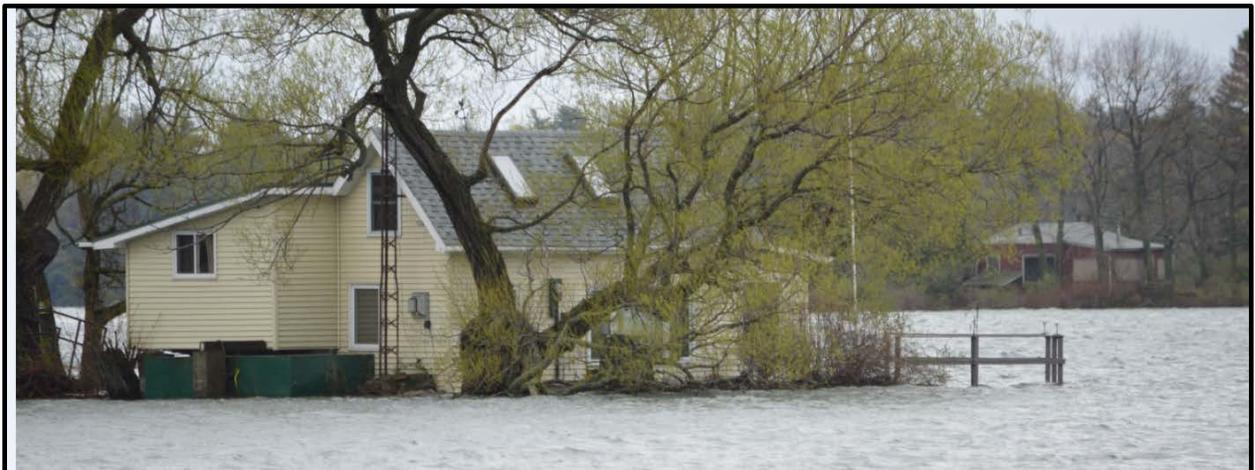
Figure 6-62: High water in the Thousand Islands area of St. Lawrence River, May 7, 2017. (Source: International Joint Commission)

There is a particularly strong linkage between shoreline property owners and recreational boating along the Canadian shoreline between Kingston and Cornwall. In many cases, and particularly in the Thousand Islands, shoreline property owners have docks and boathouses along the shoreline that were impacted by high water through prolonged inundation and wave action. Direct damages to docks or accessory shoreline buildings such as boathouses were not included in either the coastal or recreational boating PIs from the LOSLRS. In addition, many island properties in the area are only accessible by boat access meaning that impacted docking facilities on the mainland or at their islands can significantly impact use of the property. There is anecdotal information to suggest that docks, boathouses and access to property was significantly impacted in the Thousand Island area in 2017. Photos from site visits in May and June 2017 illustrate a few of the more extreme examples (see Figure 6-62 and Figure 6-63). At this point, it is not possible to quantify the full extent of these problems.

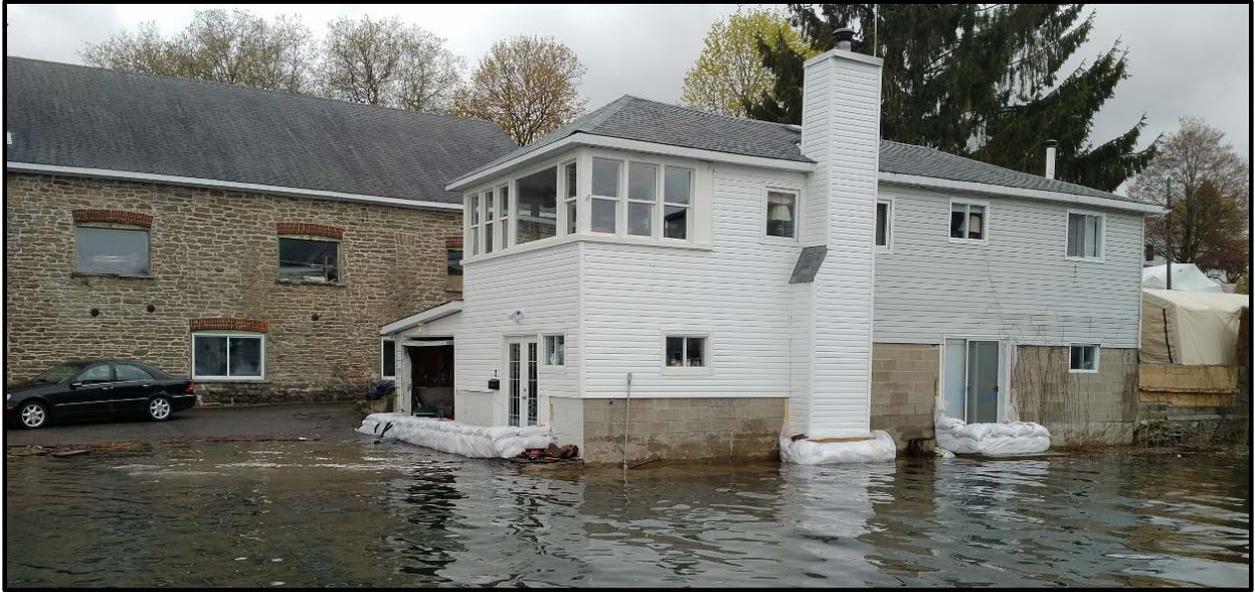
Figure 6-63: High water in the Brockville area of the St. Lawrence River, May 7, 2017. (Source: International Joint Commission)

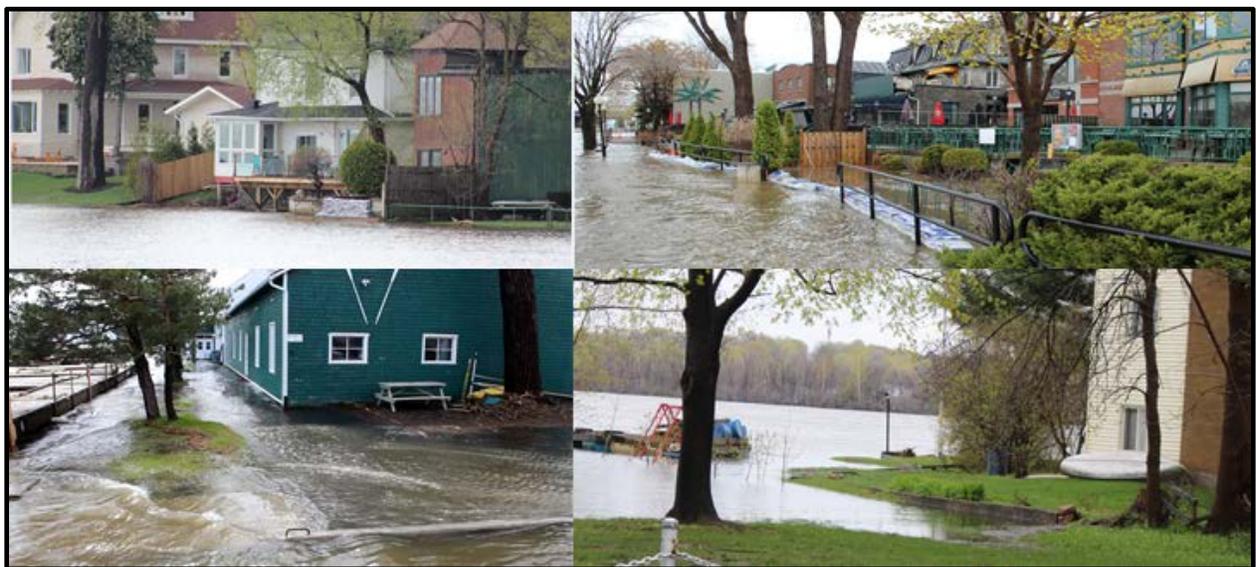
Figure 6-68: Illustrations of flooding in the Lake Saint-Louis Area on May 6, 2017. Photo credit: ECCC.

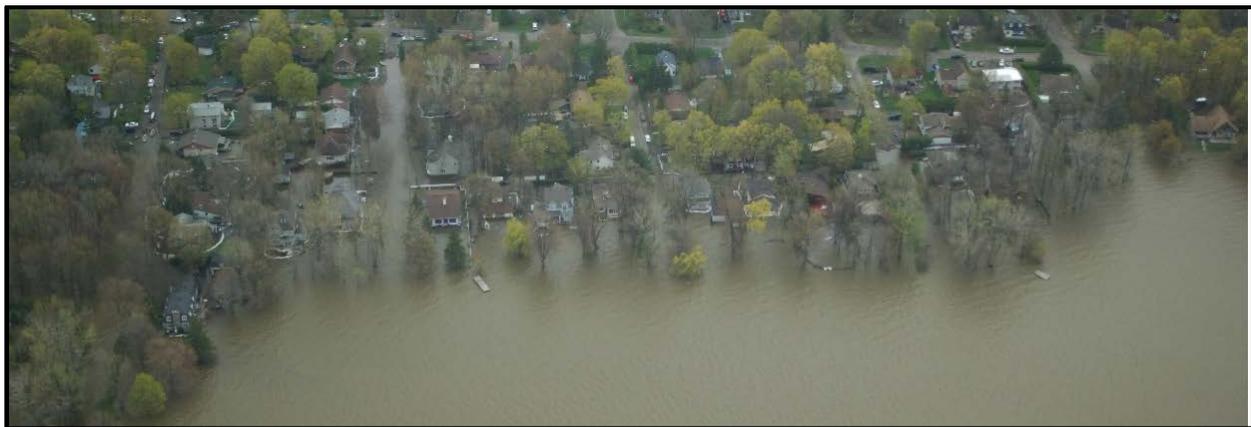
Figure 6-72: South shore of Lake of Two Mountains on May 8, 2017. Photo credit: Transport Canada National Aerial Surveillance Program.

areas are highlighted where there appeared to be clusters of impacted buildings and they are color coded based on a count of the number of buildings that appeared to have water around their foundation. Figure 6-72 shows an example of the oblique imagery for a portion of Lake of Two Mountains that was included in the interpretation to illustrate observed impacts.

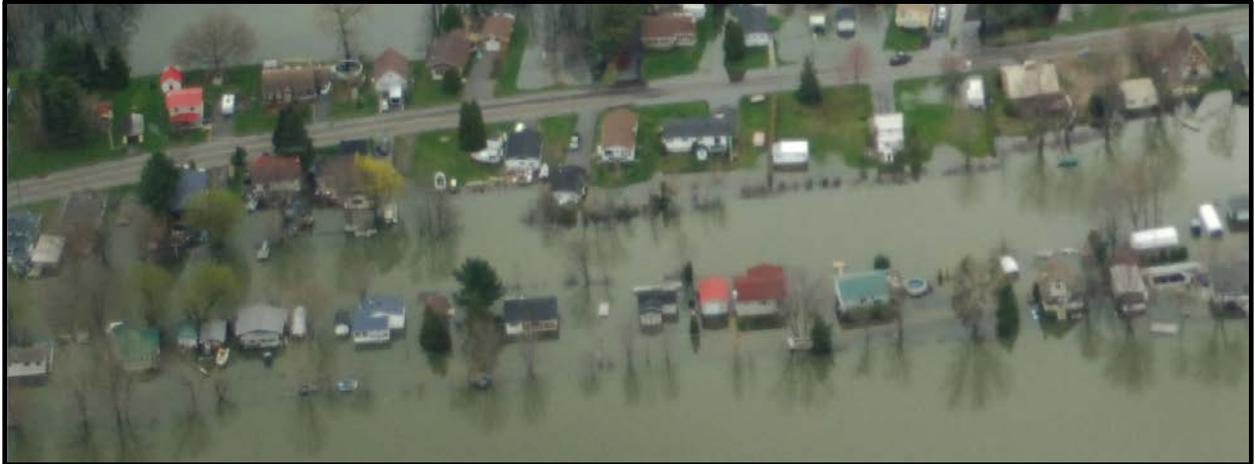
Figure 6-74: High water in the Chenail-du-Moine area near Sorel on May 9, 2017. Photo credit: Transport Canada National Aerial Surveillance Program.

In general, there are more RCMs with impacted properties in the central and eastern portions of Lake Saint-Pierre towards Trois-Rivières but there were a number of municipalities where impacts were not reported, but it is not clear why (Figure 6-73). For example, Figure 6-74 shows an oblique photograph that illustrates impacted buildings from the Chenail-du-Moine area near Sorel on the St. Lawrence River. However, there are no results for that municipality on the impacted properties map based on the information reported in the Centre des Operations Gouvernementales summaries.

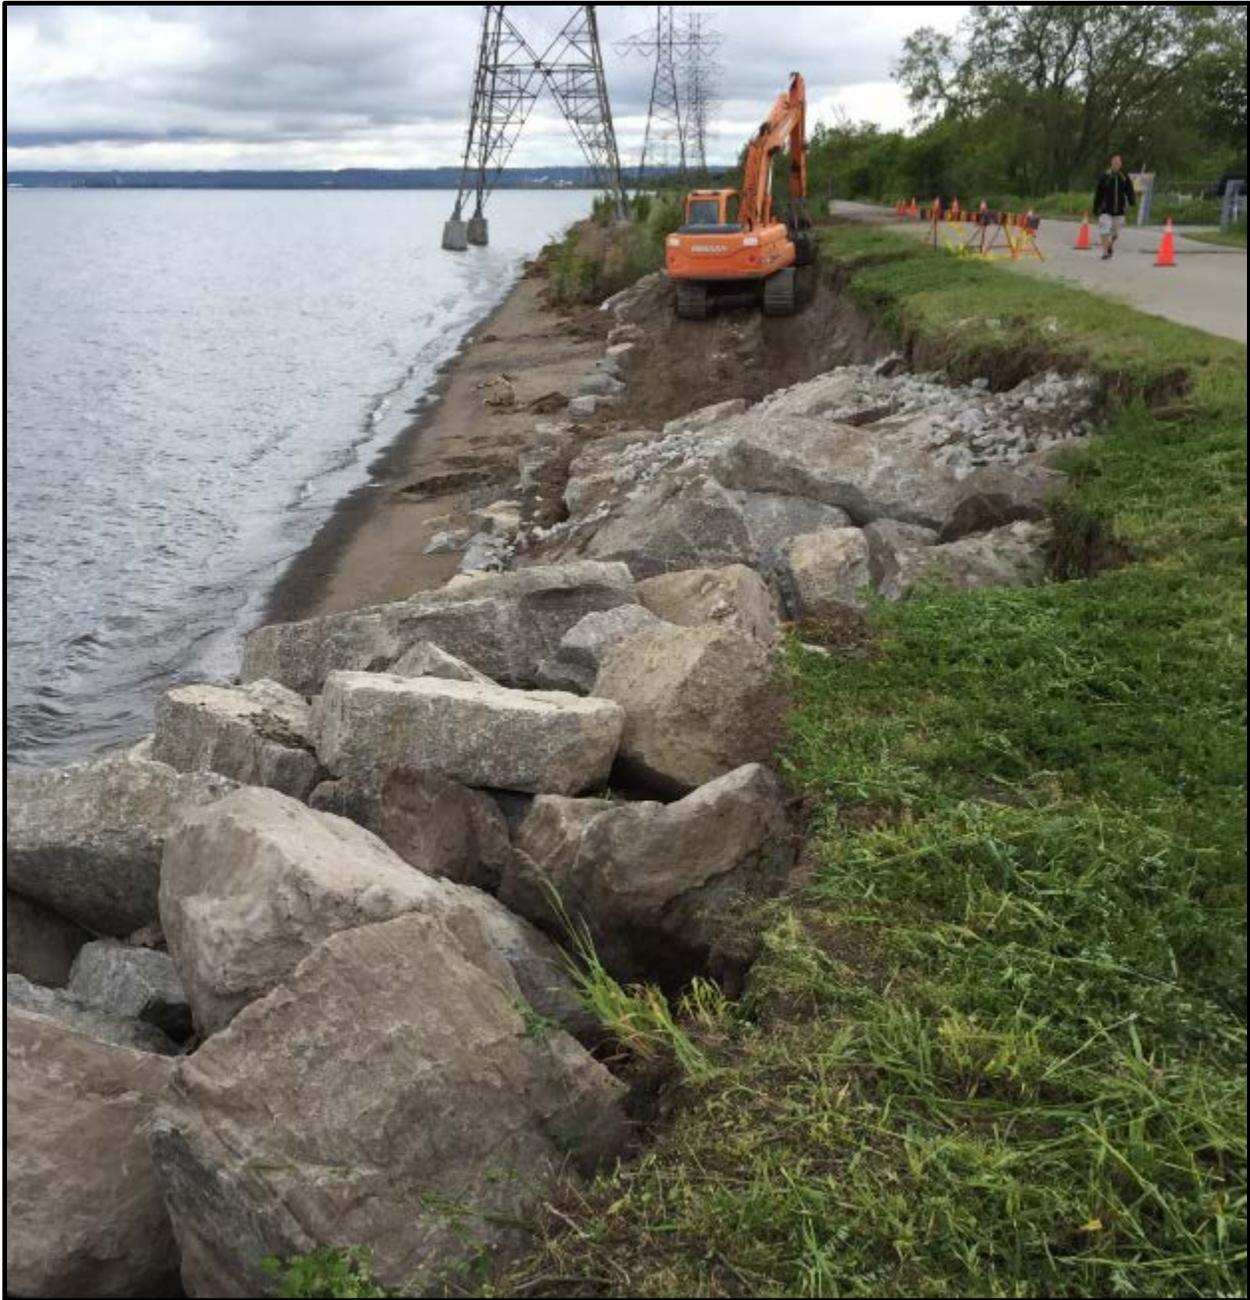
Figure 6-80: Emergency shore protection installation to protect a portion of Hamilton's waterfront trail from erosion on June 1, 2017. Photo credit: ECCC.

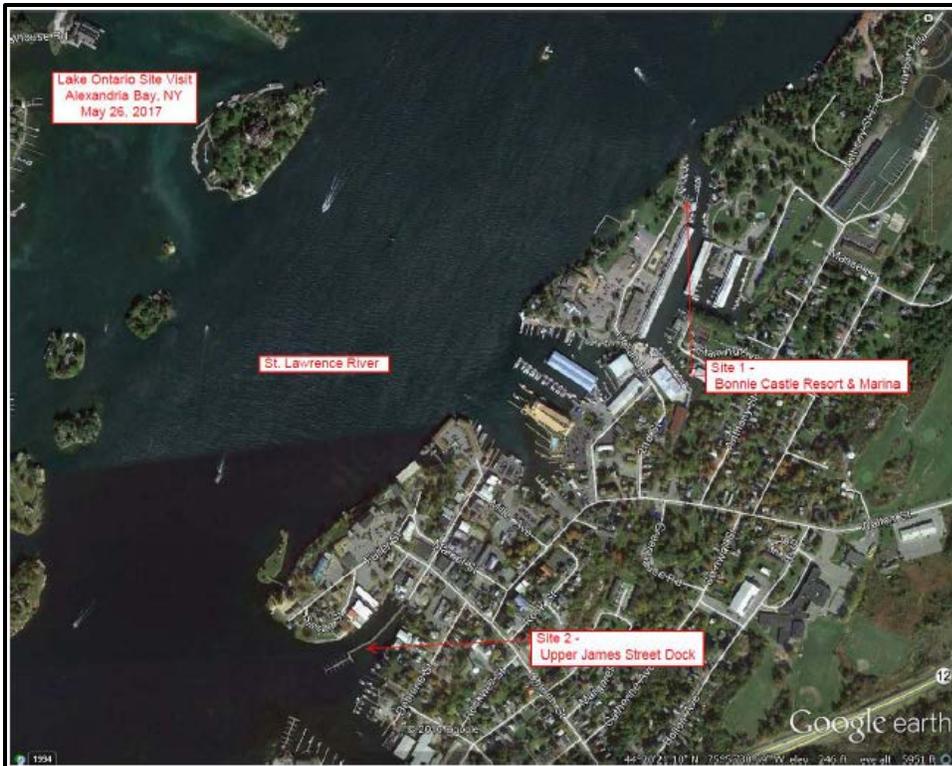
Figure 8-7: Impacted locations in Alexandria Bay, NY, May 26, 2017. Photo credit: USACE Buffalo.

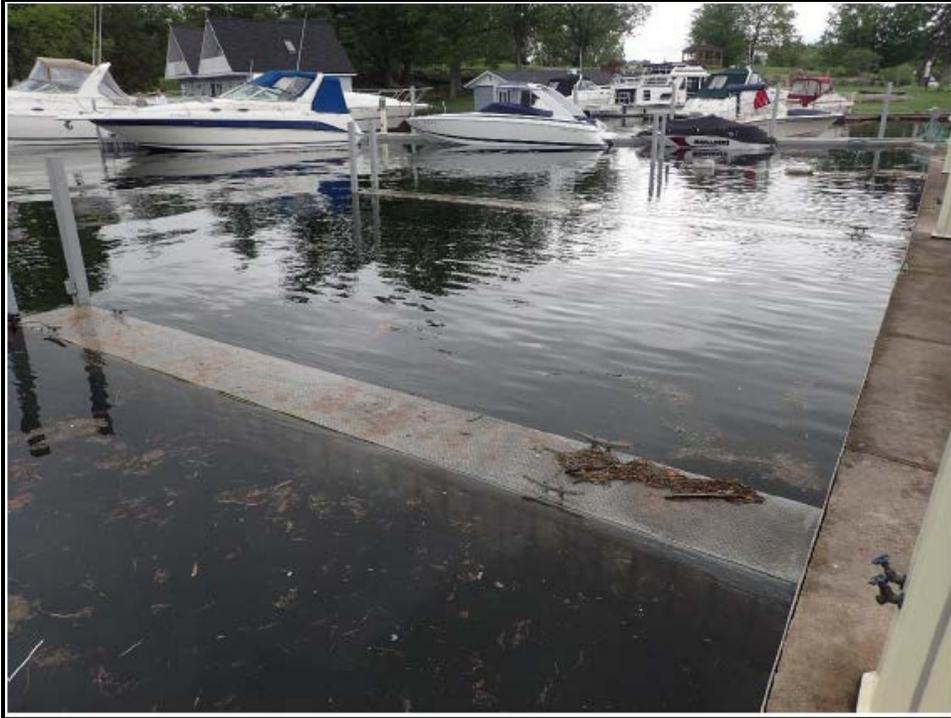
Figure 8-8: High water at Bonnie Castle Resort Docks, Alexandria Bay, NY, May 26, 2017. Photo credit: USACE Buffalo.

Staff from the USACE identified some recreational boating impacts during their site visits (discussed in the coastal section). In Alexandria Bay, NY two recreational boating facilities were identified as impacted by flooding: Bonnie Castle Resort and Marina and the Upper James Street Dock (Figure 8-7). Bonnie Castle Resort and Marina boat ramps had been closed due to debris and underwater hazards (Figure 8-8). The Upper James Street Dock was underwater and closed to the public (Figure 8-9). Two additional marinas in the vicinity were flooded and gas pumps had been shut down. As an adaptive action, local commercial interests constructed a floating dock adjacent to the existing dock at Upper James Street (Figure 8-10).

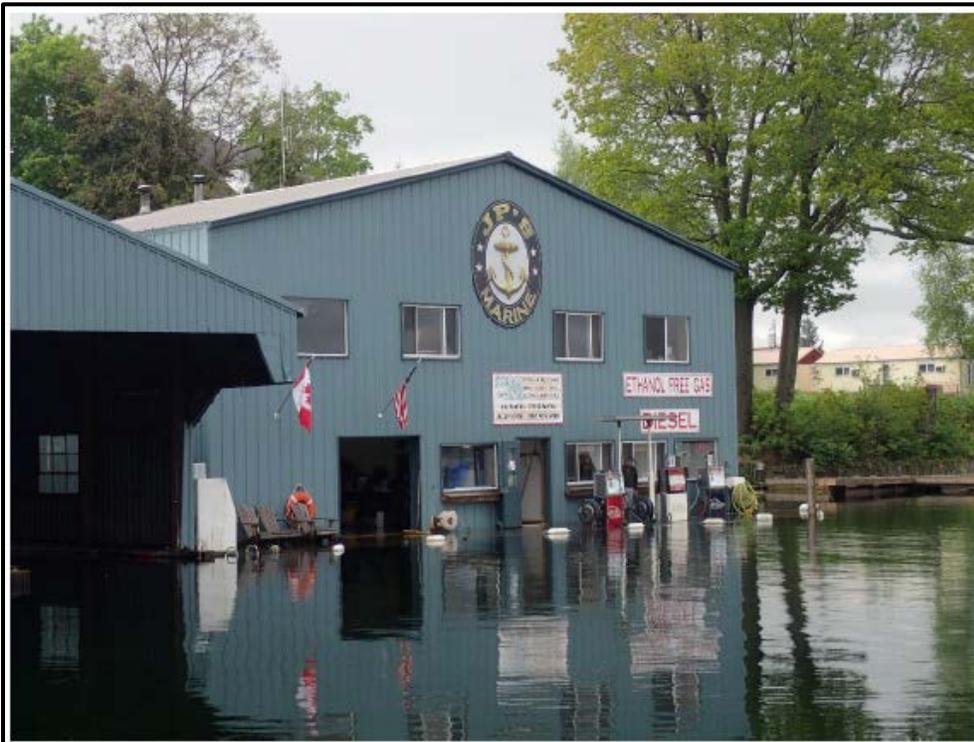
Figure 8-9: Upper James Street Marina flooding, Alexandria Bay, NY, May 26, 2017. Photo credit: USACE Buffalo.
