Great Lakes - St. Lawrence River Adaptive Management (GLAM) Committee

Annex 1:

Supplementary impact assessment information for Lake Ontario and the St. Lawrence River

November 26, 2018

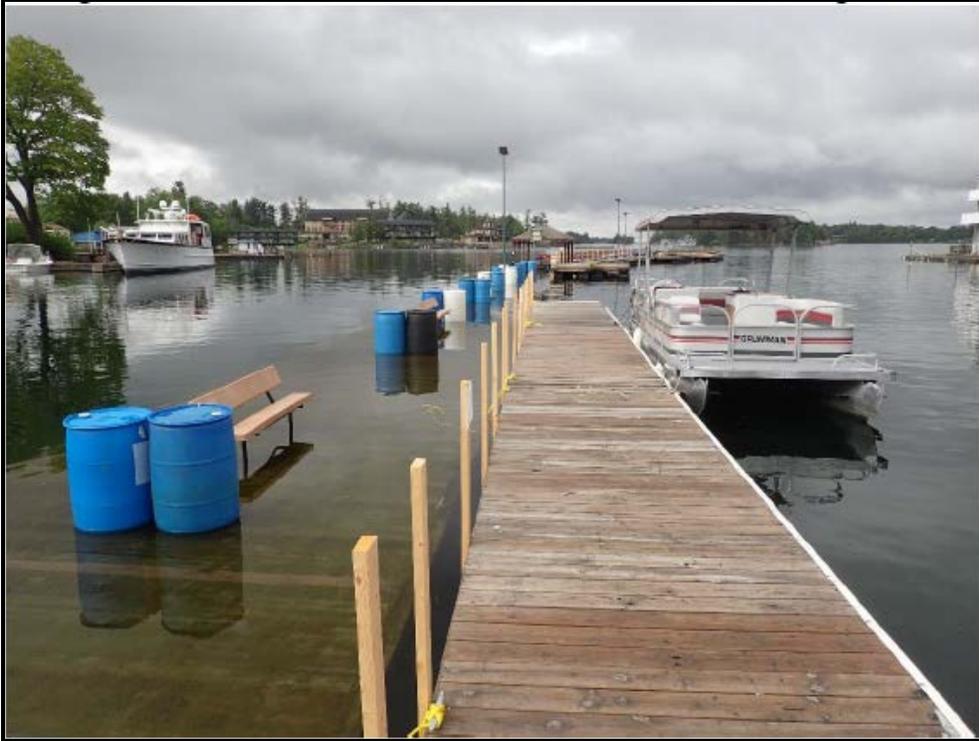
Figure 8-10: Upper James Street floating dock addition, Alexandria Bay, May 26, 2017. Photo credit: USACE Buffalo.

Staff from the USACE identified some recreational boating impacts during their site visits (discussed in the coastal section). In Alexandria Bay, NY two recreational boating facilities were identified as impacted by flooding: Bonnie Castle Resort and Marina and the Upper James Street Dock (Figure 8-7). Bonnie Castle Resort and Marina boat ramps had been closed due to debris and underwater hazards (Figure 8-8). The Upper James Street Dock was underwater and closed to the public (Figure 8-9). Two additional marinas in the vicinity were flooded and gas pumps had been shut down. As an adaptive action, local commercial interests constructed a floating dock adjacent to the existing dock at Upper James Street (Figure 8-10).

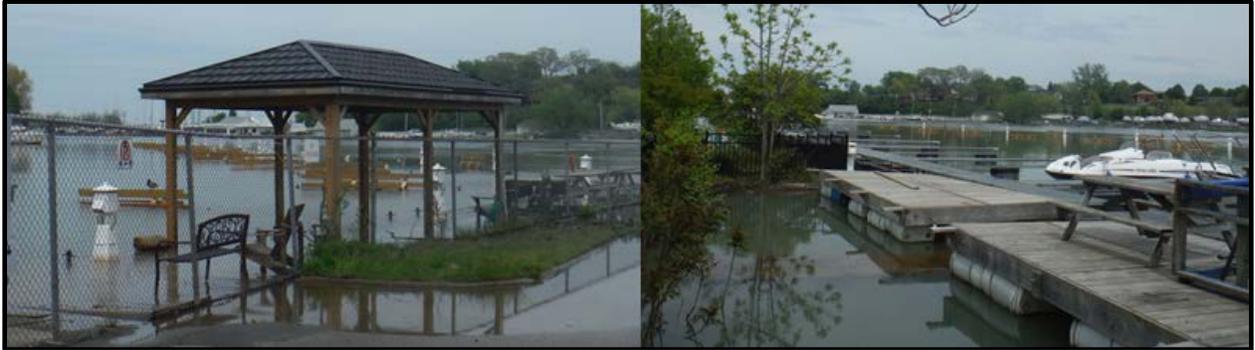
Figure 8-11: Inundation of docks at Lakeside Park in Port Dalhousie (left) and a set of floating docks in the same area (right). Photo credit: ECCC, May 24, 2017.

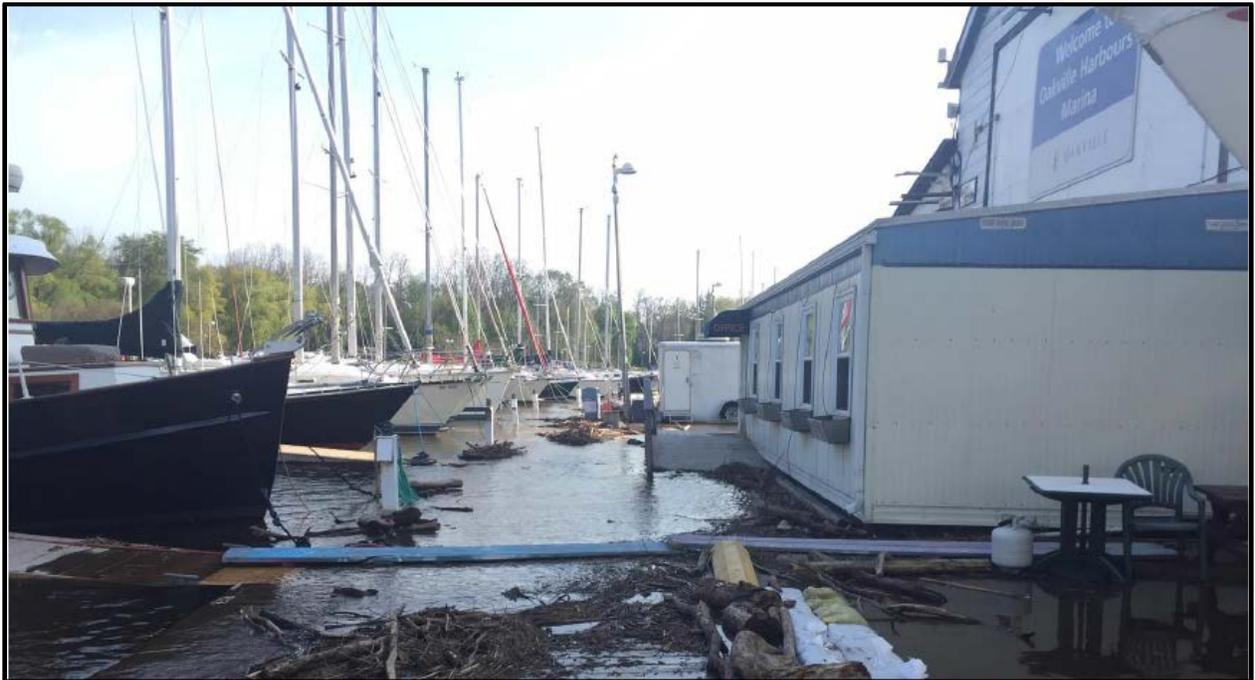
Figure 8-12: Bronte Harbour Marina (City of Oakville), May 17, 2017. Photo credit: City of Oakville – May 23, 2017 staff report.

The City of Oakville reported issues with boat launching at marinas operated by the City and a shortened boating season impacting slip rentals (Figure 8-12) (City of Oakville, 2017). In addition, various boating infrastructure repairs were required by the City of Oakville including dock rebuilding, bracket replacement, boardwalk replacement and, most significantly, the replacement of the Bronte boat launch ramp which suffered significant structural damage requiring closure and a complete rebuild (currently planned for 2018) with a large capital expenditure (City of Oakville, 2018). In Mississauga, repairs and hydro relocations had to be carried out at Credit Village Marina and Lakefront Promenade Marina to mitigate service disruption while operating costs and revenue impacts have not yet been reported by the City (City of Mississauga, 2017). Marina Park boat launch, charter boat docks and portions of gravel and asphalt parking lots remained inaccessible. Some seasonal slip charter boats relocated to Credit Village Marina, while others cancelled their slip for the season (City of Mississauga, 2017).

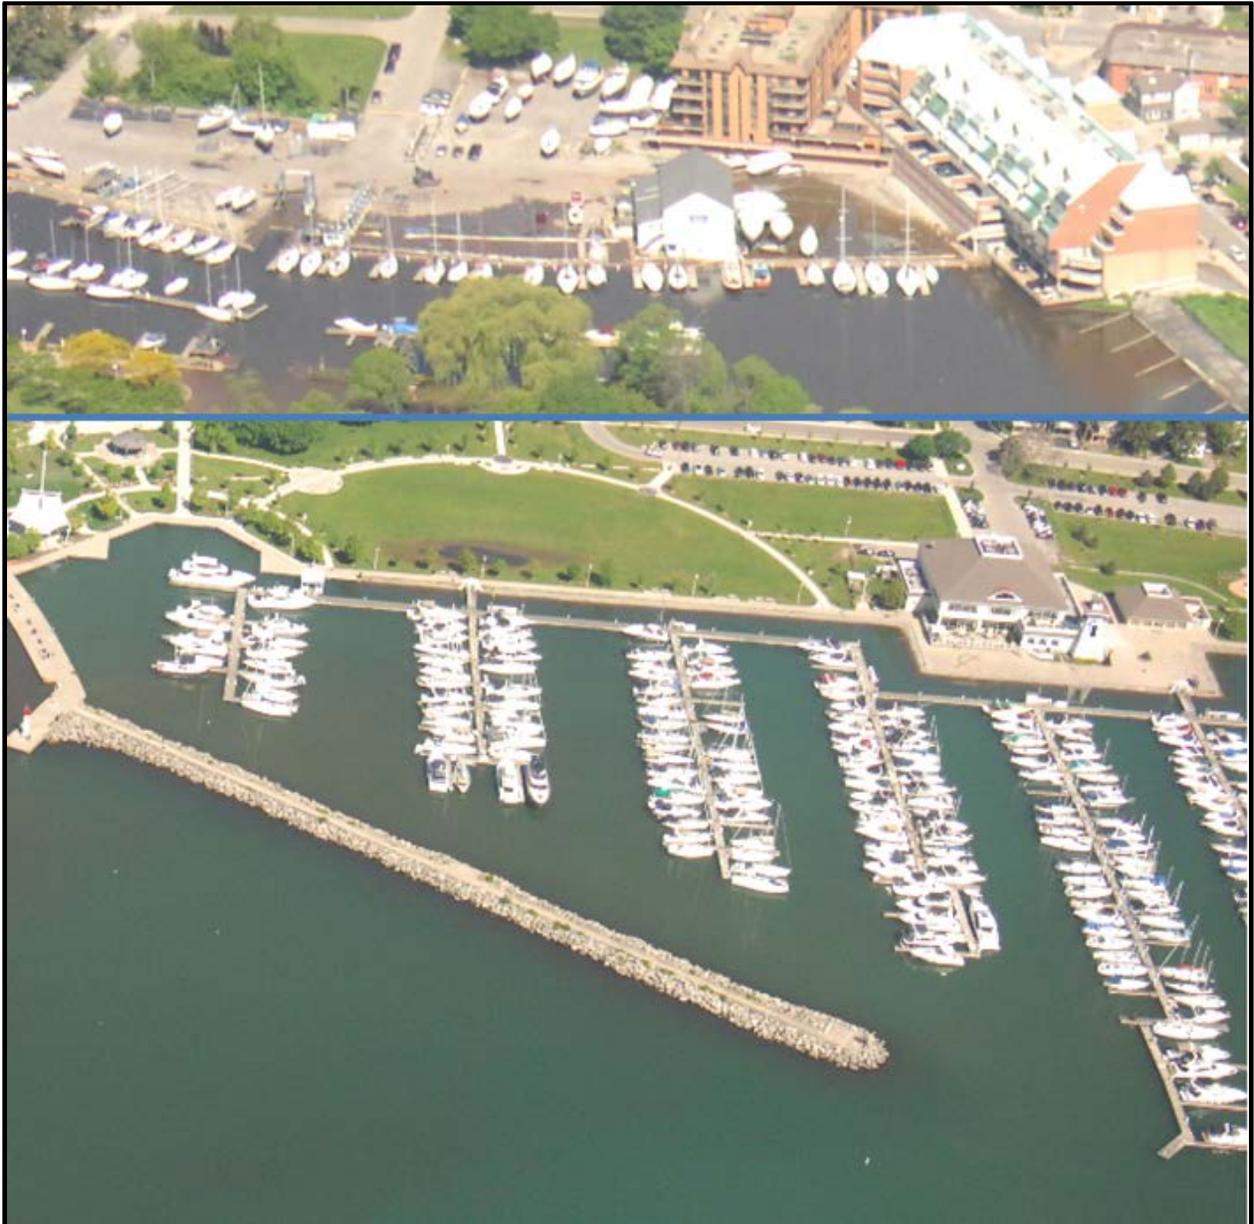
Figure 8-13: Marina facilities in the Town of Oakville, Ontario illustrating inundation of shoreline features (top) and nearby facilities that appear to have limited impacts (bottom). Photo credit: Transport Canada - National Aerial Surveillance Program, June 8, 2017.

A preliminary review of the oblique photography taken June 8, 2017 in the Region of Niagara through the Region of Peel illustrated a range of impacts to recreational boating facilities such as flooding of marina property, docks, buildings, decks, parking lot, roads, boat launches and the facility in general. To attempt to identify how high water levels may impact the boating facilities' business, inundated boat docks/slips were identified from the oblique imagery and are represented in Figure 8-5 on a relative scale across the Lake Ontario shoreline area covered by the oblique photography. The identified locations include private docks, boathouses and boat launches. The imagery review process is highly subjective so the results are intended to be descriptive, and not absolute. Of the fifteen marinas from Niagara to Peel that could be viewed using the June 8, 2017 oblique imagery, five were considered to have boat slips or docks inundated (e.g. Figure 8-14), seven additional marinas had other property features that appeared to be impacted by flooding such as property, boat launches and buildings (e.g. Figure 8-13), and

three did not have direct impacts to docks or other facilities that could be readily observed from the imagery (e.g. Figure 8-14).

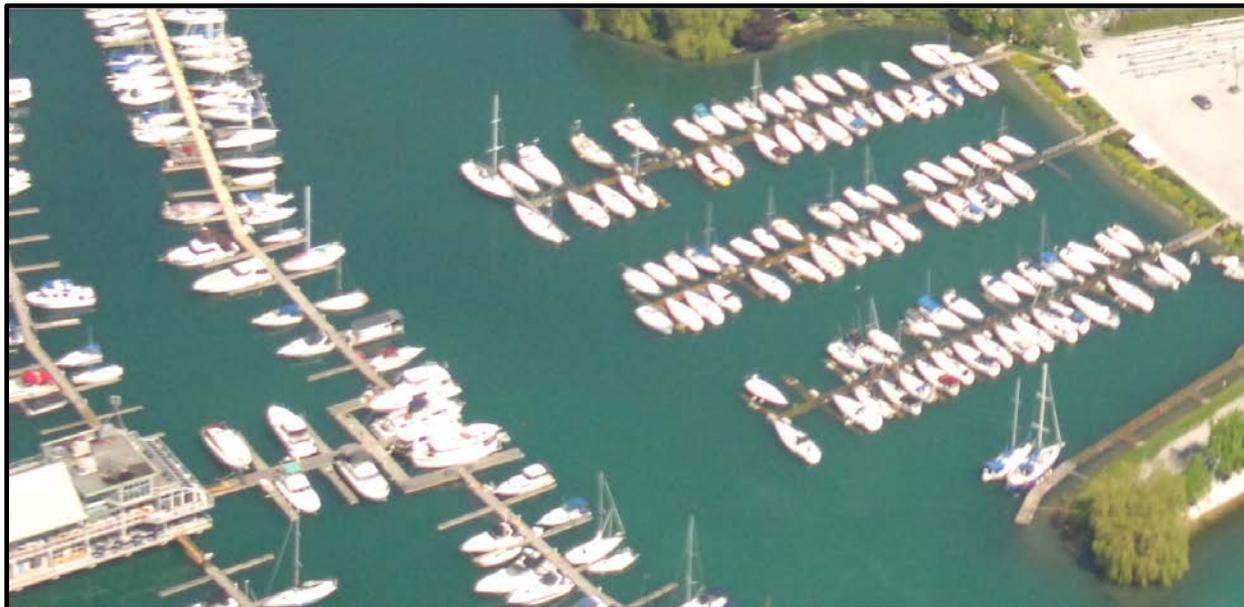
Figure 8-14: Marina facilities in Scarborough, Ontario illustrating inundation of docks (right) and docks that appear to not be inundated (left). Photo credit: Transport Canada - National Aerial Surveillance Program, June 8, 2017.

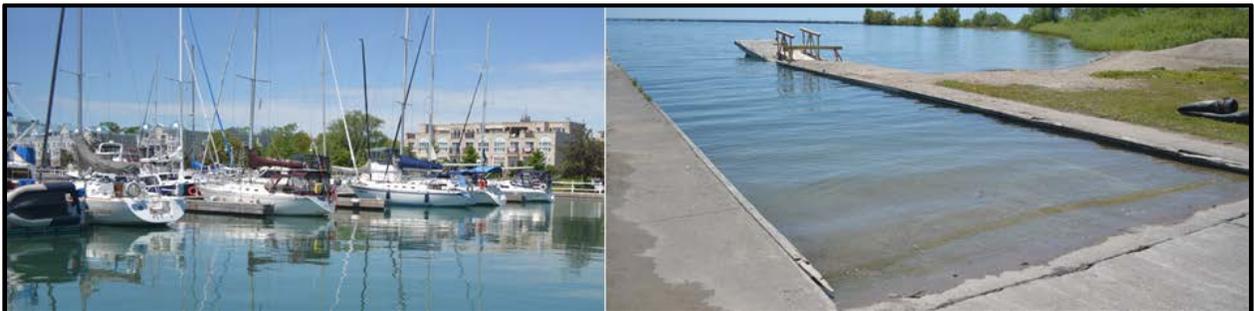
Figure 8-15: Cobourg Harbour and boat ramp, June 14, 2017. Photo credit: ECCC.

One marina in Northumberland County completed the shoreline impacts survey by Conservation Ontario in 2017. The marina respondent did not indicate any damages to the marina. Based on site visits to a number of locations, impacts to recreational boating facilities varied across the region. Figure 8-15 shows a portion of Cobourg Harbour on June 14, 2017 with floating docks (left) and boat launch (right) that, while impacted by high water levels, appeared to remain operational. In contrast, a municipal boat launch in nearby Brighton was closed on the same day and some fixed docks remained underwater on July 25, although floating docks in the background illustrate the potential difference in vulnerability based on the type of facility (Figure 8-16).

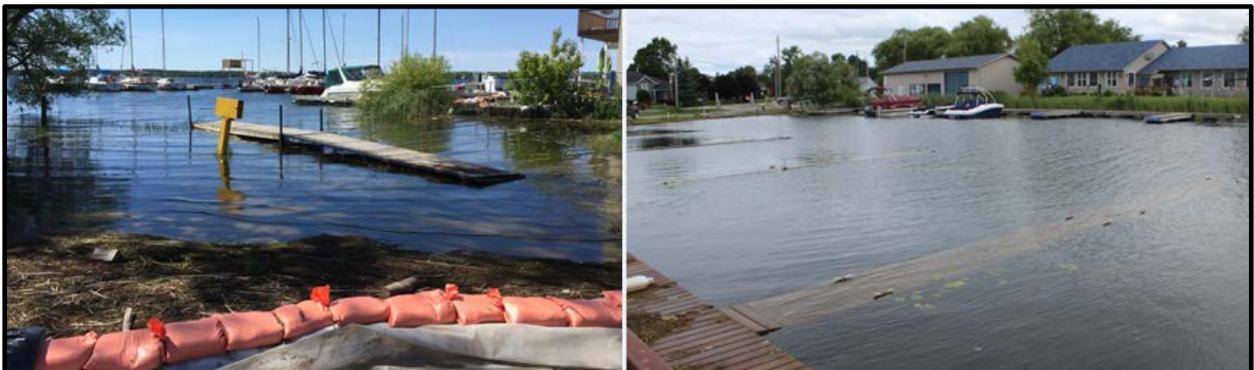
Figure 8-16: Flooded boat ramp at the Municipality of Brighton Bay Street Marina on June 14, 2017 (left). Photo credit: ECCC and flooded docks (right), also in the Brighton area on July 25, 2017. Photo credit: ECCC.

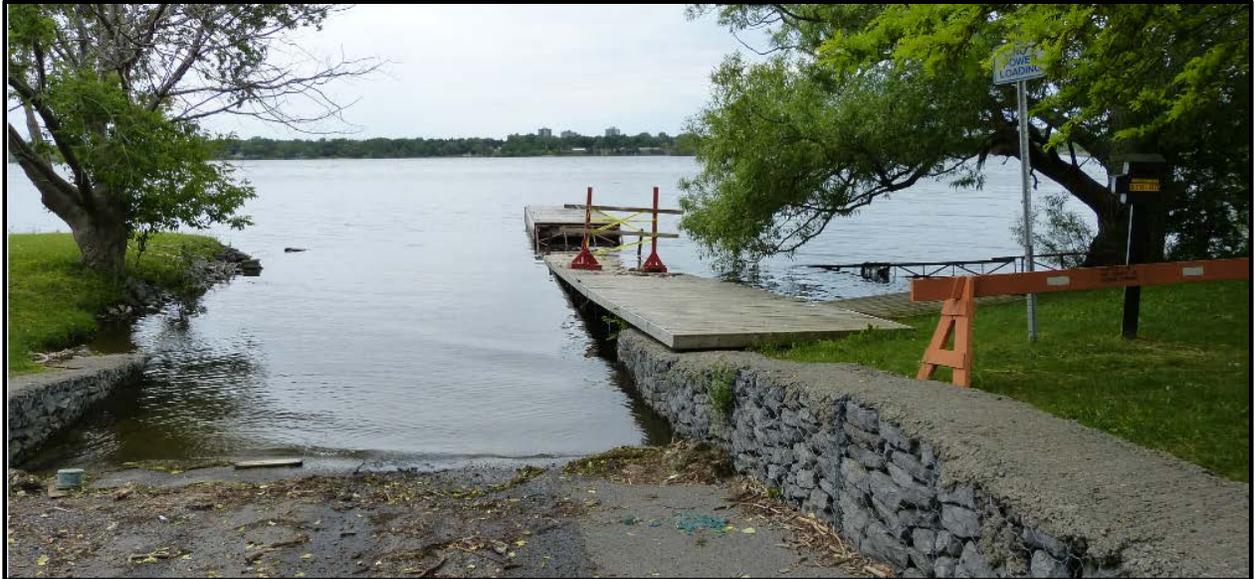
Figure 8-17: Boat launch in the Belleville area, June 15, 2017. Photo credit: ECCC.

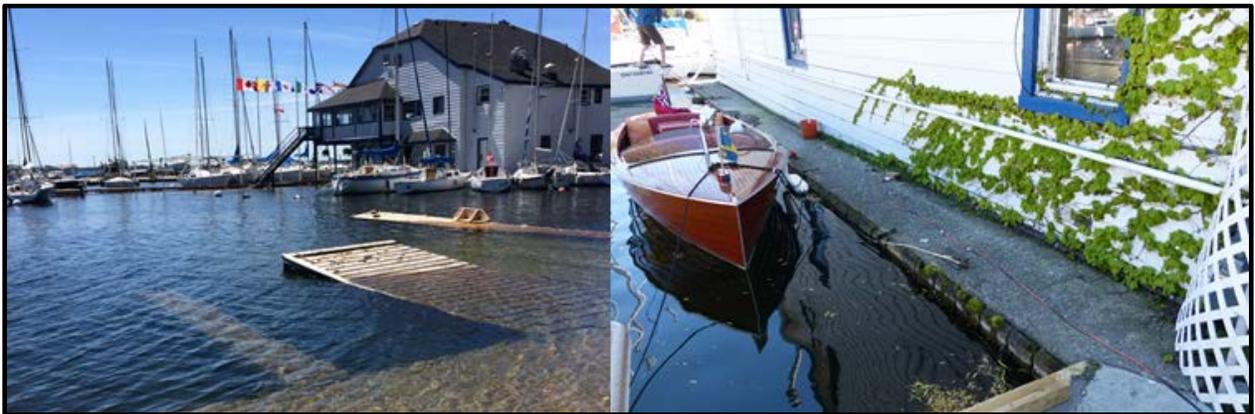
Figure 8-18: Kingston Yacht Club, June 14, 2017. Photo credit: ECCC.

Recreational boating is particularly important in the upper St. Lawrence River, both with regards to general recreational use and also to access numerous island properties. High water impacts were identified at marina and yacht club facilities throughout the region. The Cataraqui Region Conservation Authority highlighted marina and boat ramp problems associated with flooding in the Kingston area. For example, they note the boat ramp and gas dock at the Kingston Yacht Club were closed due to flooding as of May 31 and the boat ramp at Kingston Penitentiary/Portsmouth Olympic Harbour was closed. Further east towards Gananoque and the Thousand Islands, the Ivy Lea and Mallorytown public docks and boat ramps were closed and a number of marinas were inundated (e.g. Andress Boat Works in Rockport as identified during site visits). A Cataraqui Region Conservation Authority boat ramp was also closed in the Brockville area. Figures 8-18 and 8-19 document some of these impacts.

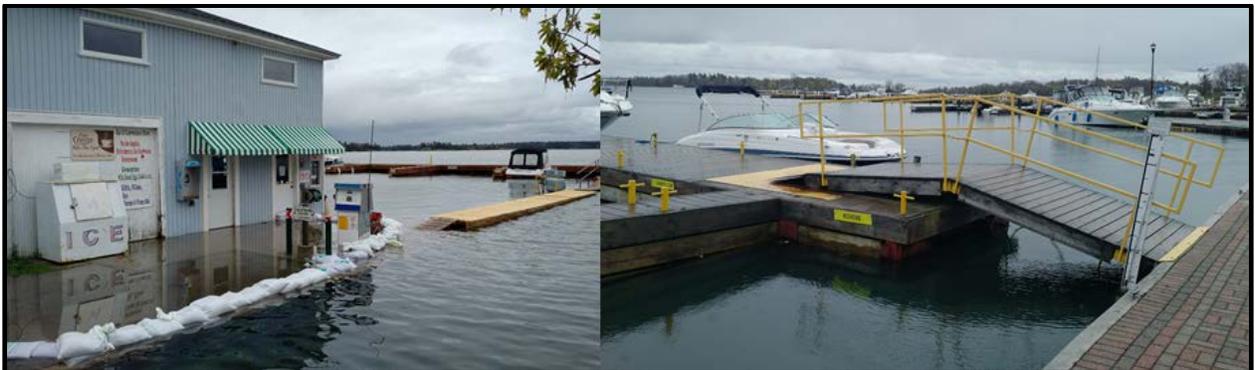
Figure 8-19: Marina facilities in the Gananoque area of the Thousand Islands, May 7, 2017. Photo credit: International Joint Commission.

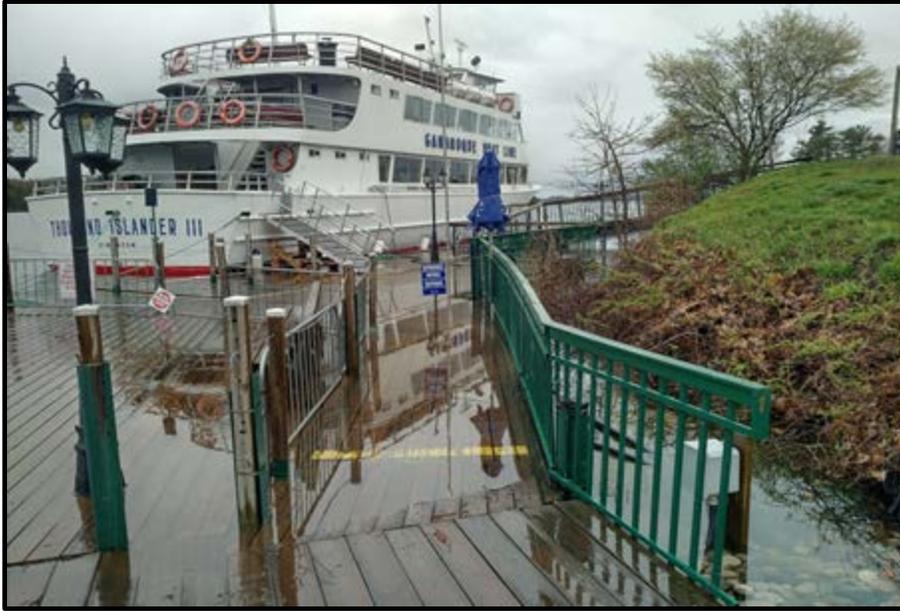
Figure 8-21: Example from tour boat operations in the Thousand Islands area, May 7, 2017. Photo credit: International Joint Commission.

Three marinas in this region completed the shoreline impacts survey by Conservation Ontario in 2017. One marina did not experience any impacts, but the other two marina respondents indicated fixed docks and utility infrastructure flooding. One marina respondent indicated flooding up to the building foundation. One indicated that the club house built on cribs almost flooded and that the marina's gas dock was flooded and forced to close. One respondent noted a disruption to the marina's floating docks system noting that chains were broken and anchors were moved. A number of private shoreline residents in this area also reported impacts to docks (see Figure 8-21).

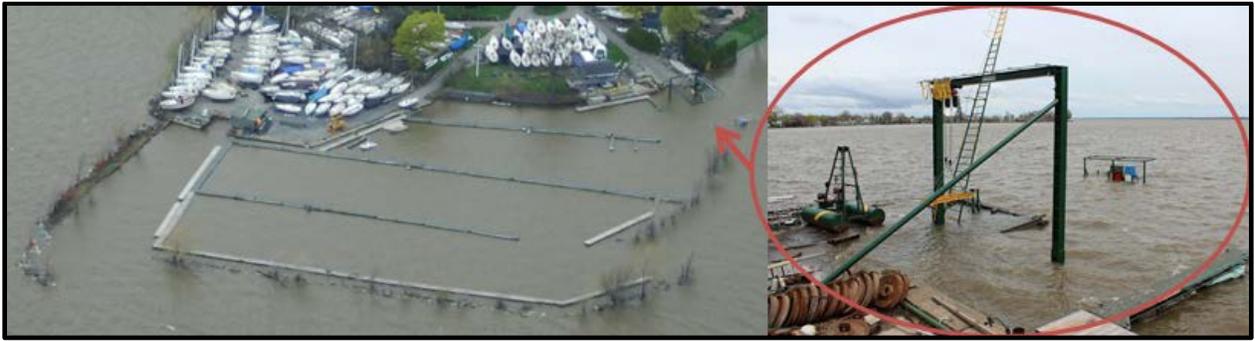
Figure 8-24: Beaconsfield Yacht Club showing inundation to a portion of the shoreline facilities on May 7, 2017. Photo credit: (left) Transport Canada - National Aerial Surveillance Program, (right) ECCC, May 5, 2017.

In the Lake Saint-Louis area, inundation of boating facilities was observed in May and corroborated by site visit photos in the area or by earlier imagery as available through Google Earth and other sources (Figure 8-24 to 8-26). The available sources are not considered to provide a comprehensive reflection of impacts. A number of the marina and yacht club facilities updated their members through websites and social media updates. The majority of the updates on impacts took place during late April and early May as water levels peaked. Various marinas indicated they were pushing back their put-in dates for installing their floating docks due to the high levels and inundation of necessary facilities (e.g. anchor points for floating docks were inundated or it was unsafe for staff to work near the shoreline). Since the peak flooding occurred relatively early in the boating season, few boats were in the water at the time the oblique imagery was taken and there were examples where floating docks did not appear fully set up for the season yet. Similar observations were made using the available imagery along the St. Lawrence River between Montreal and just upstream of Sorel (e.g. Figure 8-27).

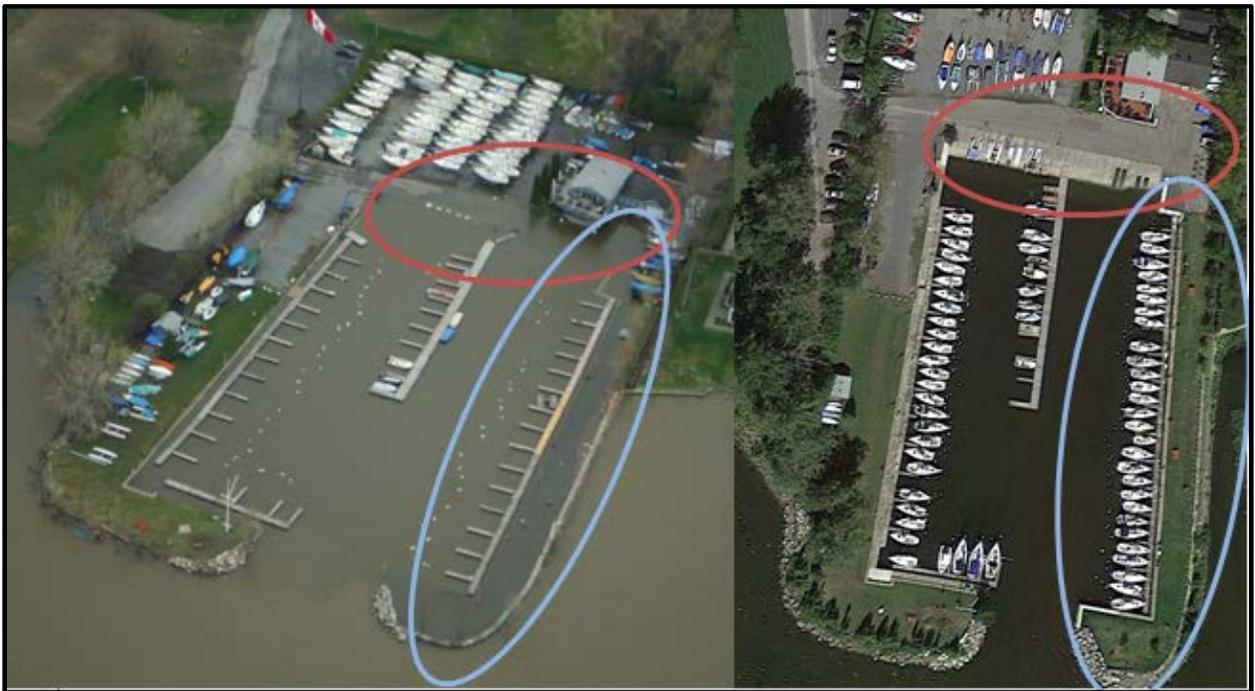
Figure 8-25: Baie-d'Urfe Yacht Club showing inundation of shoreline areas on May 8, 2017 (left) relative to lower water level conditions in September 2013 (right). Photo credit: (left) Transport Canada - National Aerial Surveillance Program, (right) Google Earth, September 17, 2013.

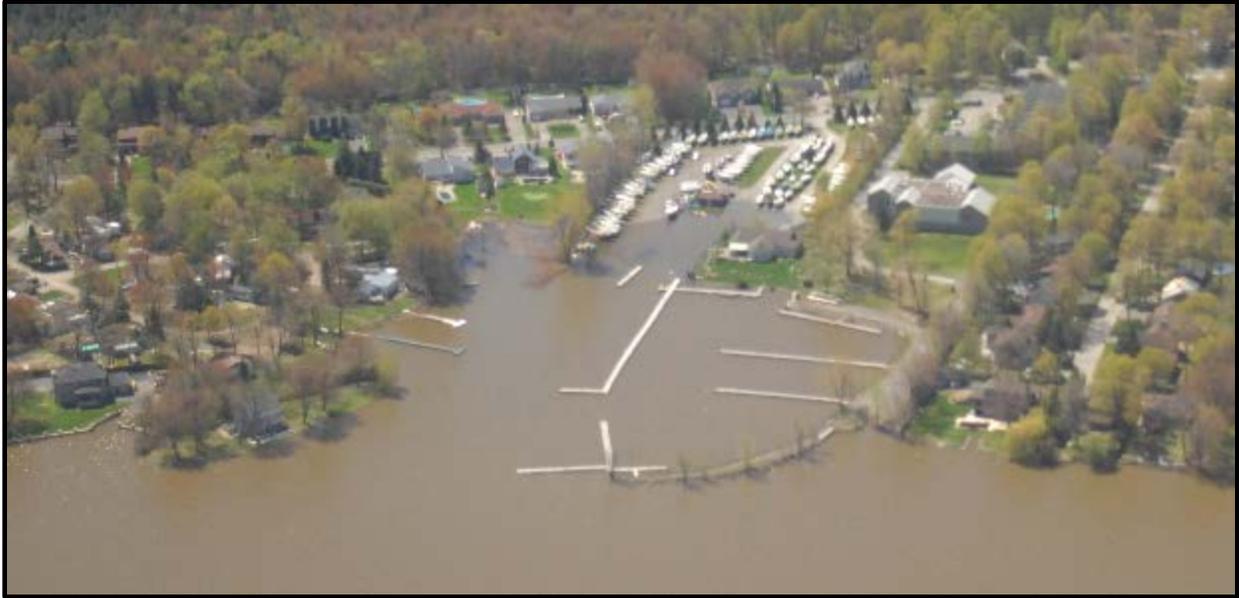
Figure 8-26: Club de Voile Ile Perrot on May 12, 2017 illustrating shoreline inundation. Photo credit: Transport Canada - National Aerial Surveillance Program.

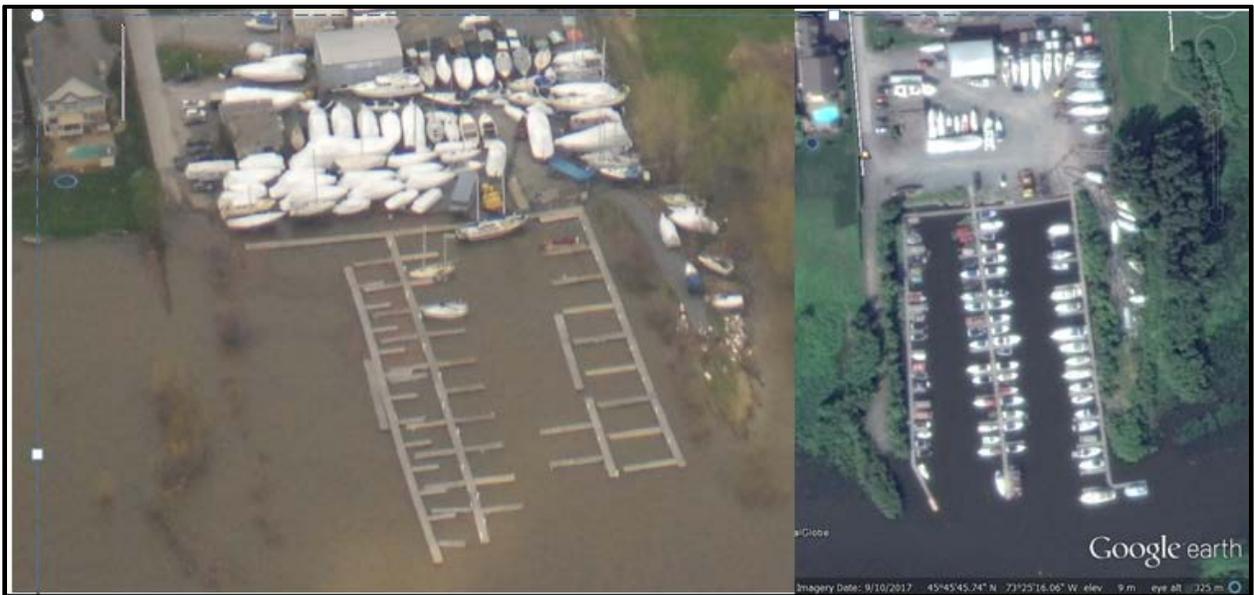
Figure 8-27: Marina de la Rive Nord on May 11 (left) and September 10, 2017 (right) Photo credit: Transport Canada - National Aerial Surveillance Program (left) and Google Earth (right)

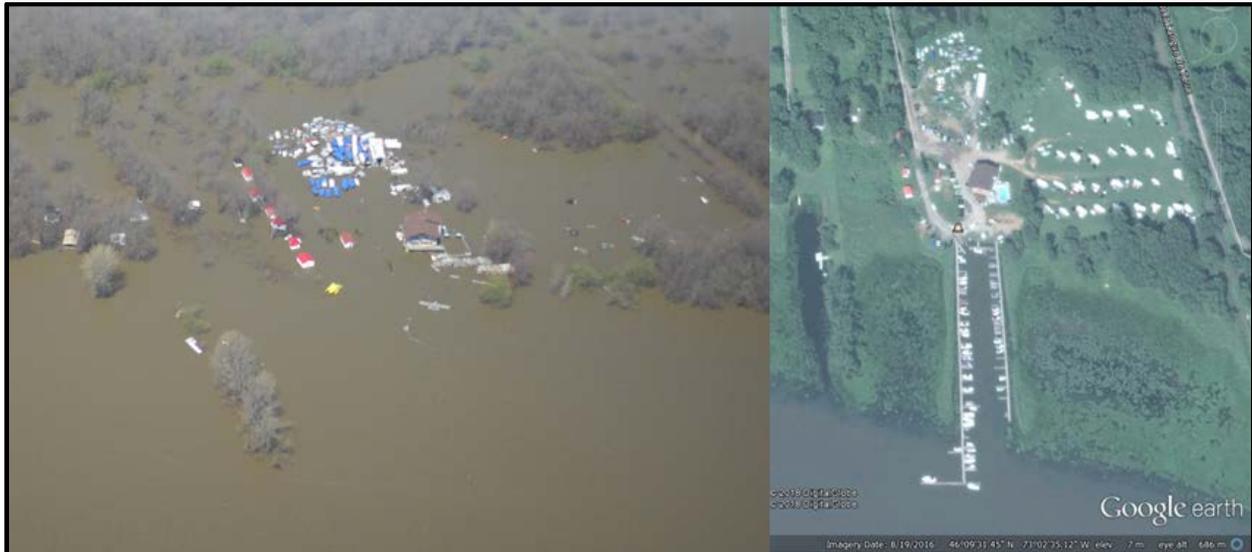
Figure 8-28: Marina Le Nid D'aigle on May 11 (left) and August 19, 2016 (right) for reference. Photo credit: Transport Canada - National Aerial Surveillance Program (left) and Google Earth (right)

Marinas and recreational boating facilities in the Lake Saint-Pierre area were also impacted by the high water conditions in early May. Like areas further upstream, a number of locations delayed their put-in date and there was flooding of boat ramps and other facilities. This was evident through the oblique imagery (e.g. Figure 8-28 and 8-29). There were also reports of a high amount of debris getting pushed up onto the shoreline for various facilities based on the combination of high water levels and waves. Due to the resolution of the available imagery, it

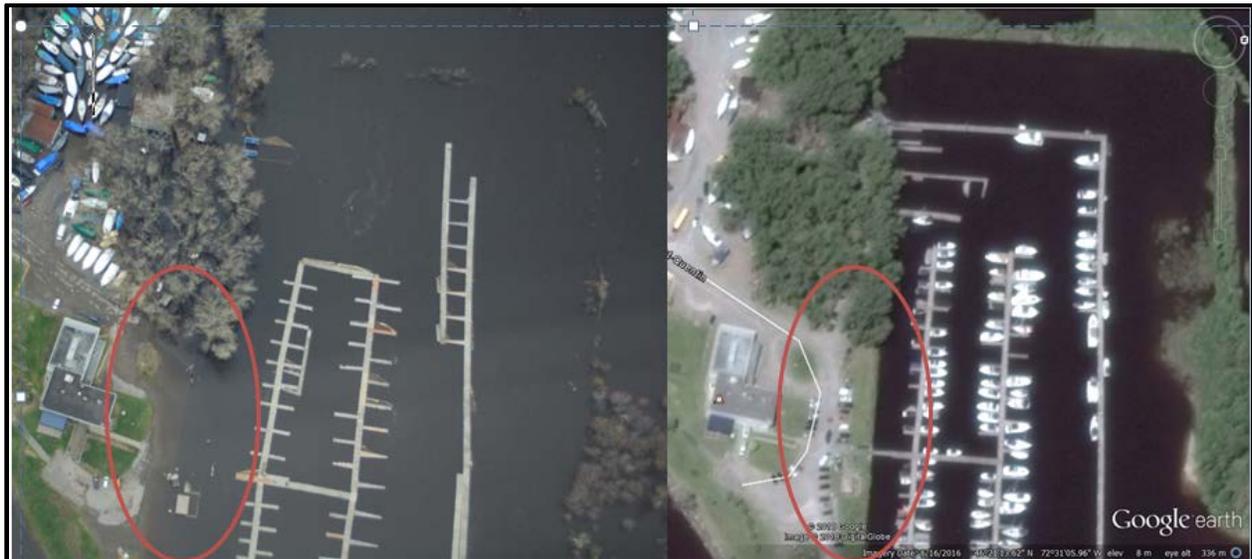
Figure 8-29: Marina de Trois-Rivières on May 9 (left) and June 16, 2016 (right). Photo credit: Transport Canada - National Aerial Surveillance Program (left) and Google Earth (right).

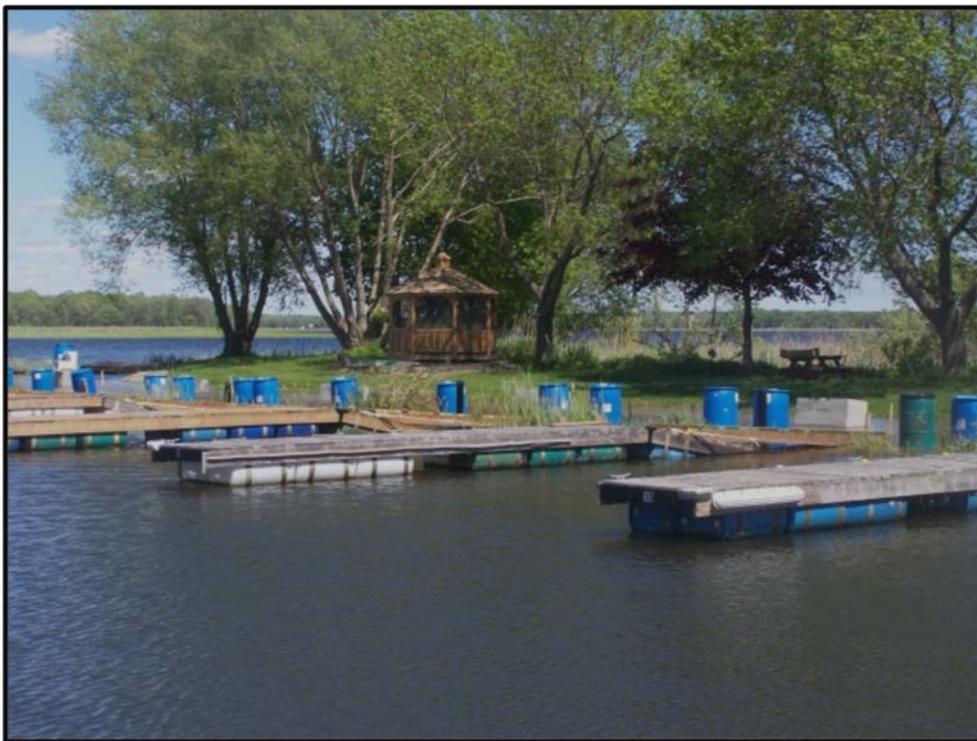
Figure 8-31: New floating docks installed at the Presqu'île Yacht Club in Brighton, ON. Action taken to adapt to extreme water levels such as those experienced in May and June 2017. Photo credit: <http://presquileyc.com/high-water-project-update/>

Some facilities appeared more resilient than others. Fixed docks primarily saw many slips inundated whereas some floating docks appeared fairly usable with modifications installed where the floating docks met the shoreline. For example, while conducting the imagery assessment of the Presqu'île Yacht Club in Brighton, ON, their website was visited and a news bulletin on the website discussed a project to adapt to high water level conditions, such as those experienced in May and June by switching all the fixed docks to floating docks. Figure 8-31 is a picture of the new floating docks installed to adapt to changing water level conditions.
