# THE CHAMBLY CANAL

# WHY ARE WE INTERESTED IN THE CHAMBLY CANAL AS PART OF OUR PRESENT STUDY?

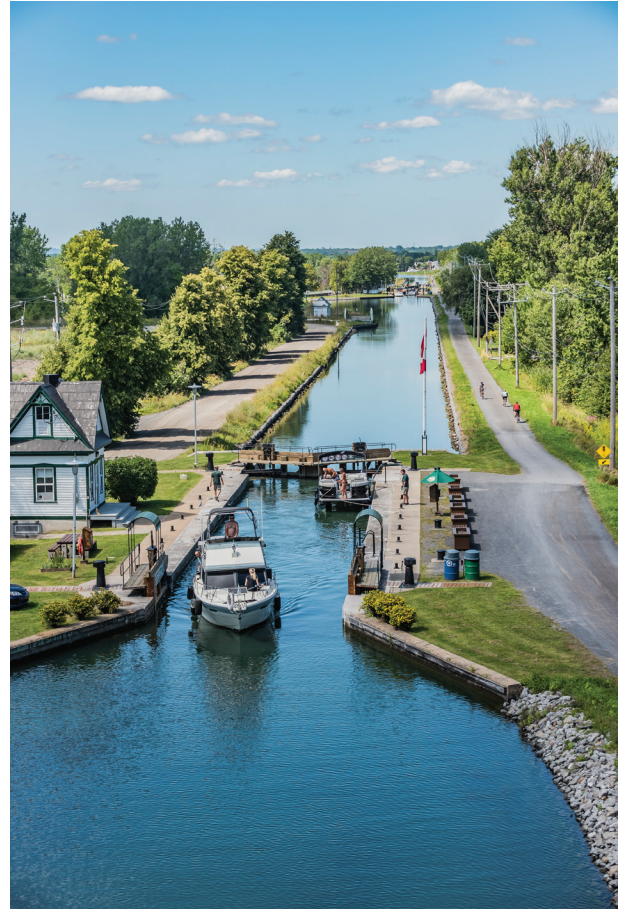
Lock No. 7 at Chambly, Quebec.  
Photo Credit: Parks Canada

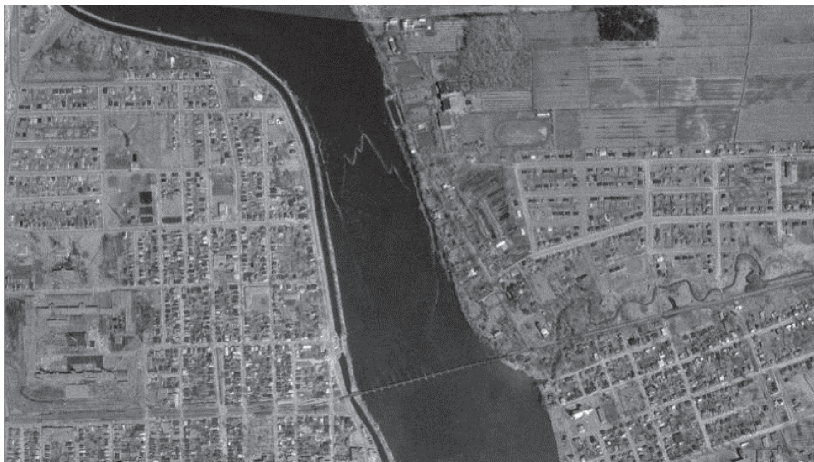
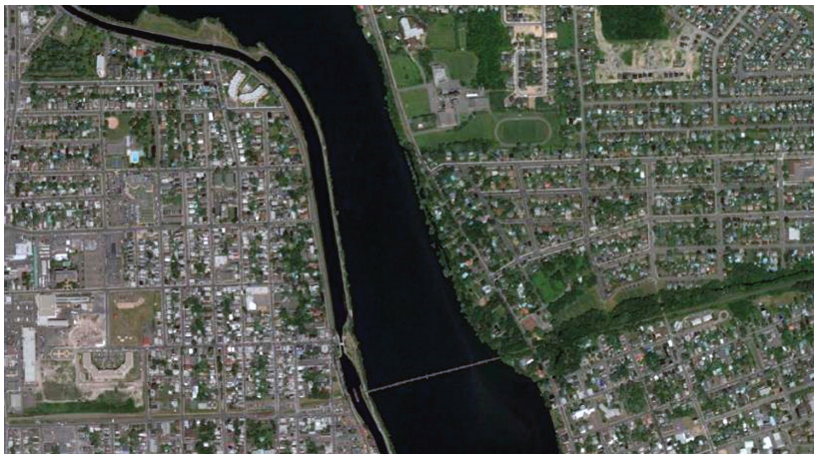
Widening of the Chambly Canal in the Saint-Jean-sur-Richelieu area was complete in 1973.  
(Top panel is before 1973.  
Bottom panel is after 1973.)  
Figure from Syed Moin.

In the early 1970s, Transport Canada widened the canal in the Saint-Jean-sur-Richelieu reach. It is thought this was done to accommodate the movement of larger vessels through it. Downstream of lock No. 9, the dyke separating the canal from the river was shifted eastward by 30.5 m (100 feet) into the main river channel, reducing the width of the river channel by the same amount. The widening of the canal in the Saint-Jean-sur-Richelieu reach was completed in 1973. The images below illustrate the extent of the widening of the Chambly Canal.

After the canal was widened, the International Champlain-Richelieu Board (ICRB) researched the impacts of this modification on lake water levels. (The ICRB was established by the International Joint Commission (IJC), which is responsible for the resolution of disputes related to water management on transboundary water bodies.) As the Saint-Jean shoals are next to the areas of the canal that were widened and act as a natural water level control, the ICRB determined that the widening of the canal led to an increase of between 3 and 10 cm (1.2- 4 in) in the level of Lake Champlain.

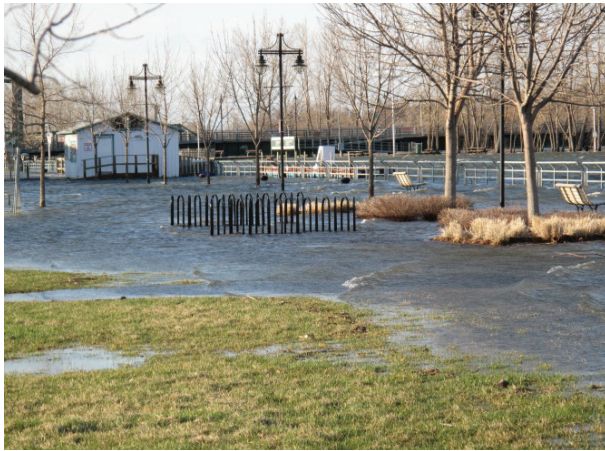
Flooding near the Chambly Canal in 2011.  
Photo by: Ville de Saint-Jean-sur-Richelieu

The main causes of the major flooding event in 2011 in the Lake Champlain-Richelieu River basin were the quick melting of a large snowpack in the basin because of warming temperatures as well as record breaking rainfall over the area from March to May 2011. This combination of conditions delivered a very large quantity of water to Lake Champlain. The increased volume in the lake quickly led to flood levels in the river, and flooding persisted for over two months as the lake slowly drained.

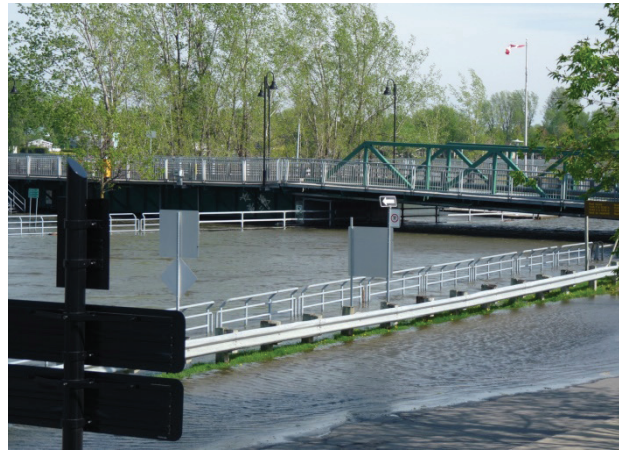
Flooding at Gouin bridge and the Chambly Canal lock in Saint-Jean-sur-Richelieu. May 23, 2011.  
Photo credit: Pierre CB.

Historic water levels and the flooding in 2011 affected Park Canada installations, including the Chambly Canal. For instance, both the dike alongside the canal and lock in Saint-Jean-sur-Richelieu were inundated and impacted by the flood. In addition, the start of the boating season was delayed as was access for visitors to several locations along the canal. In some areas, the sides of the canal were completely submerged.

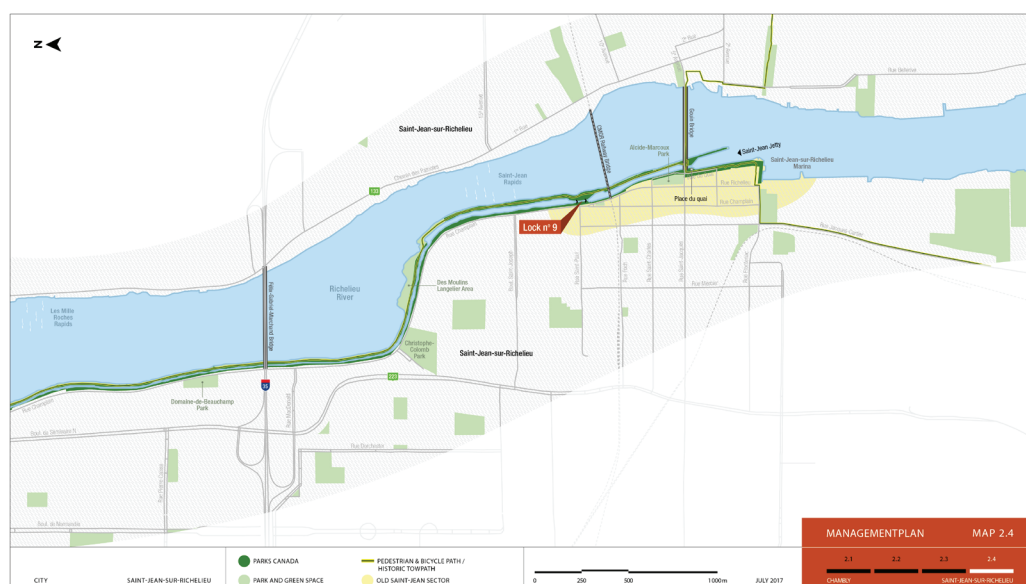
Map of the Chambly Canal near lock No 9.  
Figure from Parks Canada Management Plan.

Lake Champlain drains north, emptying into the Richelieu River. As previously noted, the Saint-Jean shoals naturally restrict the flow of the river, and water draining from Lake Champlain must flow through this small bottleneck. The widening of the canal into the river bed in the Saint-Jean shoal area increased this bottleneck effect during high flow periods.
