2014 – 2015 Operation of the Lake Erie – Niagara River Ice Boom

A report to the International Niagara Board of Control by
the International Niagara Working Committee

September 2015

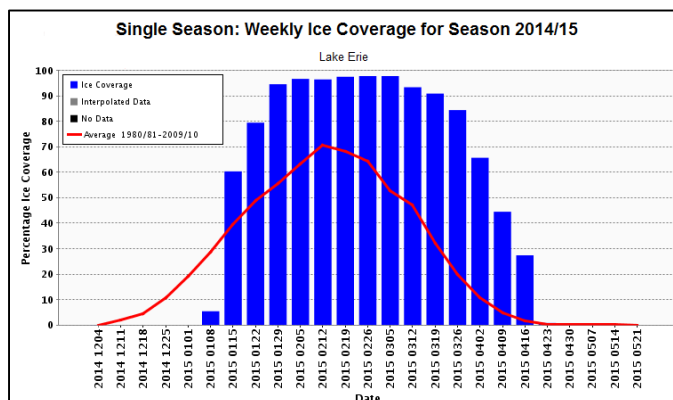
Figure 1: Single Season: Weekly Ice Coverage for 2014/15 provided by the Canadian Ice Service

The first ice of the season was observed in the Grass Island Pool on 6 January 2015. On 9 January 2015, noticeable ice began to form in the Maid-of-the-Mist-Pool (MOMP) just below the falls. By 14 January 2015, a complete ice bridge had formed in the MOMP. As shown in Figure 1, ice cover on Lake Erie peaked during the first week of March, covering nearly 98% of Lake Erie's surface area, as compared to the average peak coverage of 71% that usually occurs during the second week of February. The extent of the coverage was reduced to below 2% by 23 April 2015.

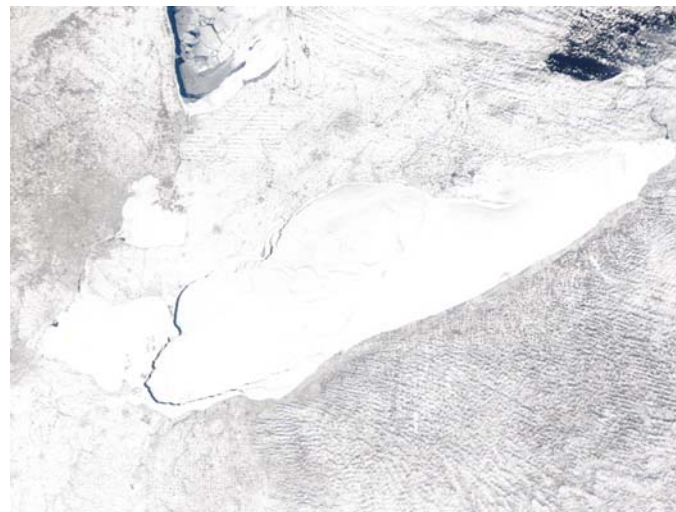
MODIS Satellite Imagery from the (NOAA) Coast Watch Great Lakes Program, 2 March 2015

MODIS images from the first week of March showed ice coverage to be near 98 percent on the eastern end of Lake Erie. The Board advised the Commission on 25 March 2015 that the extent of ice cover would likely cause a delay in the ice boom opening beyond 1 April and issued a media advisory on 26 March 2015.

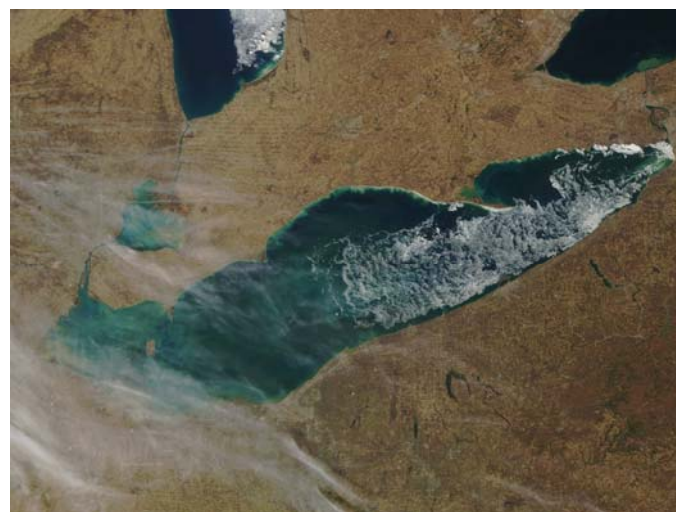
MODIS Satellite Imagery from the (NOAA) Coast Watch Great Lakes Program, 12 April 2015

A fixed wing ice observation flight that occurred on 15 April 2015 revealed 2176 km² (840 mi²) of ice remained on the eastern end of Lake Erie. After warming temperatures over the following week, MODIS satellite imagery showed that large dense ice packs had broken up and the thin surface ice had dissipated.

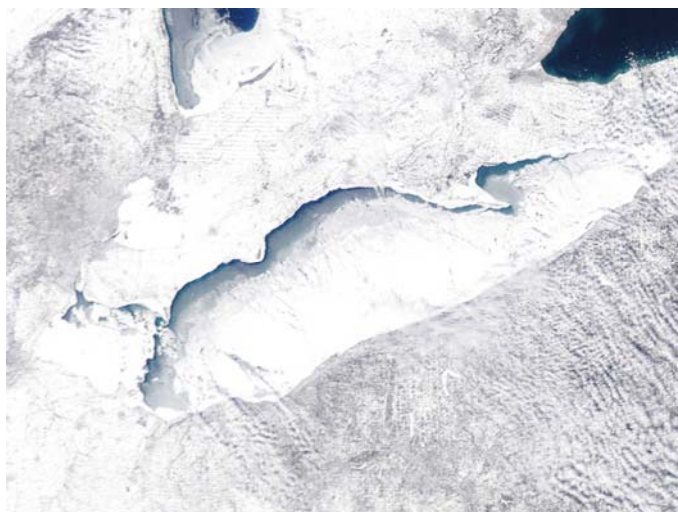
MODIS Satellite Imagery from the U.S. National Oceanic and Atmospheric Administration (NOAA) Coast Watch Great Lakes Program, 5 February 2015

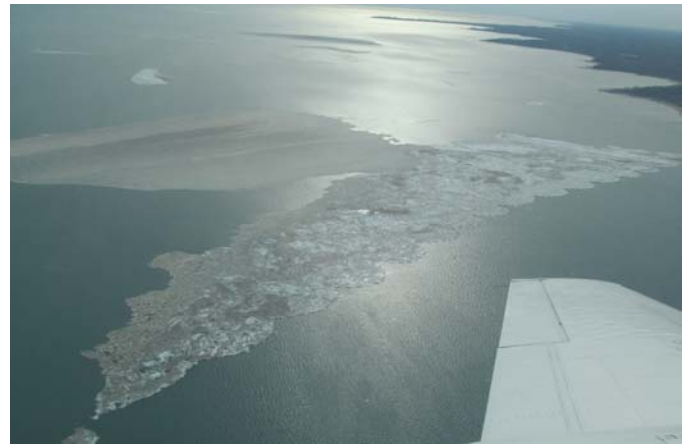
Fixed Wing Ice Observation Flight, 19 April 2015

Another ice survey flight on 19 April 2015 revealed that 218 km² (84 mi²) of ice remained on the eastern basin of Lake Erie. Considering the amount of ice remaining and the absence of ice in the MOMP below Niagara Falls, the Board issued a Media Advisory on 20 April 2015 that preparations for the boom opening were underway.
