2003-04

Operation of the Lake Erie - Niagara River Ice Boom

A report to the
International Niagara Board of Control
by the
International Niagara Working Committee

September 2004

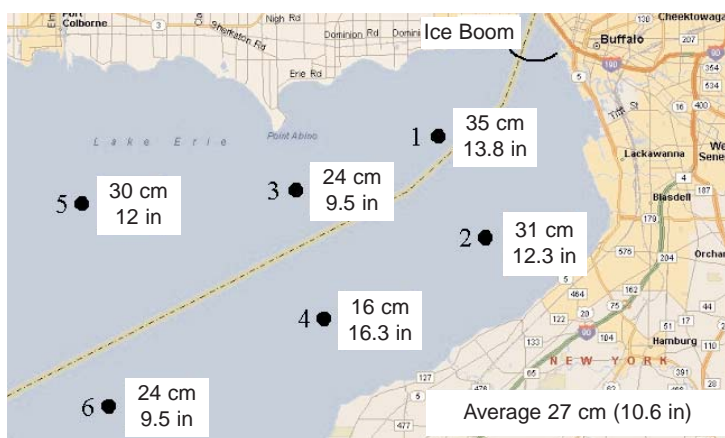
Ice Thickness Measurements - 15 March 2004

Ice thickness measurements were again taken at six sites in the eastern part of Lake Erie on 15 March, with the average thickness being 27 centimetres (10.6 inches). By comparison, similar measurements taken on 18 March 2003 resulted in an average thickness of 60 centimetres (23.5 inches) for the six sites sampled.
